# Home Report

# Scottish Single Survey

<b>Property address</b>	Culeave Cottage Ardgay IV24 3BP
<b>Customer</b>	Rosalys Holt
<b>Customer address</b>	Culeave Cottage Ardgay IV24 3BP
<b>Prepared by</b>	Shepherd Chartered Surveyors
<b>Date of inspection</b>	30/10/2025

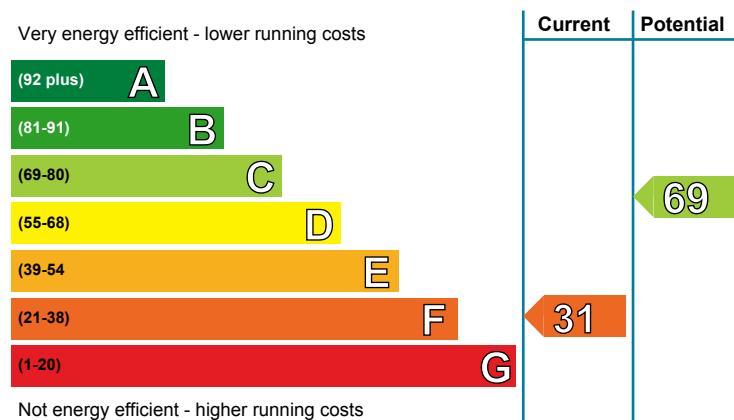
## Energy Efficiency Rating

This graph shows the current efficiency of your home, taking into account both energy efficiency and fuel costs. The higher this rating, the lower your fuel bills are likely to be.

Your current rating is **band F (31)**. The average rating for EPCs in Scotland is **band D (61)**.

The potential rating shows the effect of undertaking all of the improvement measures listed within your recommendations report.

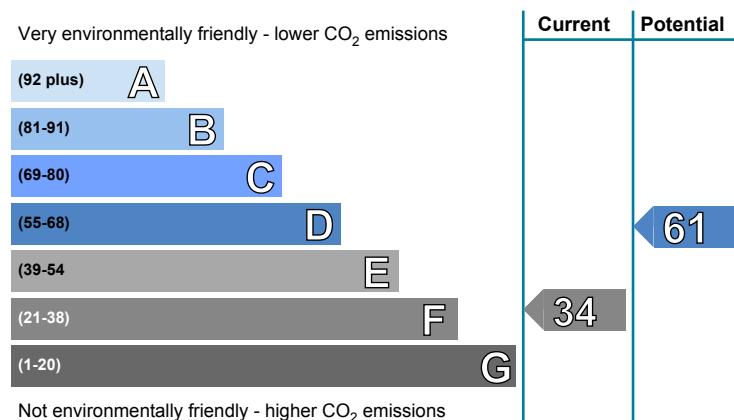
## Environmental Impact (CO<sub>2</sub>) Rating

This graph shows the effect of your home on the environment in terms of carbon dioxide (CO<sub>2</sub>) emissions. The higher the rating, the less impact it has on the environment.
