YOUR ONESURVEY  
**HOME REPORT**

45 Orchy Gardens  
Clarkston  
Glasgow  
G76 8NB

# SINGLE SURVEY

# Single Survey

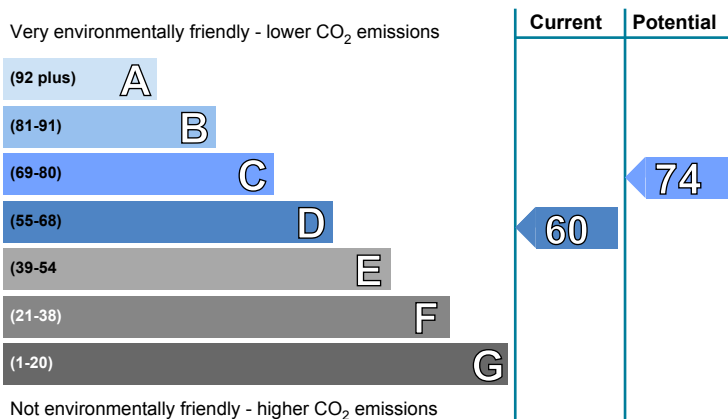
## Environmental Impact (CO<sub>2</sub>) Rating

This graph shows the effect of your home on the environment in terms of carbon dioxide (CO<sub>2</sub>) emissions. The higher the rating, the less impact it has on the environment.
