# Home Report

# Scottish Single Survey

<b>Property address</b>	1a Annfield Road Inverness IV2 3HP
-------------------------	--

<b>Prepared by</b>	Shepherd Chartered Surveyors
--------------------	------------------------------

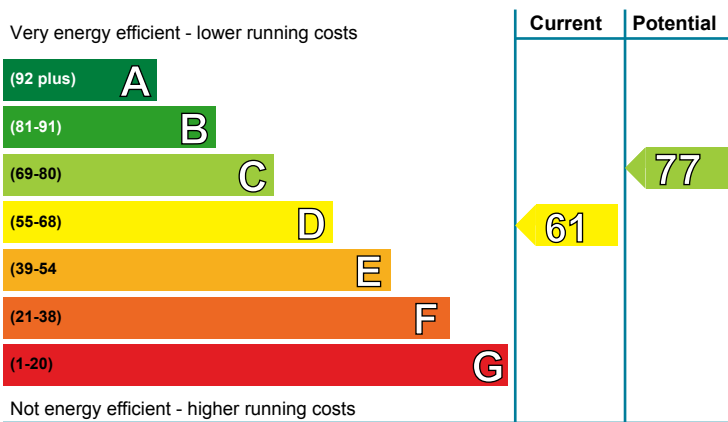
## Energy Efficiency Rating

This graph shows the current efficiency of your home, taking into account both energy efficiency and fuel costs. The higher this rating, the lower your fuel bills are likely to be.

Your current rating is **band D (61)**. The average rating for EPCs in Scotland is **band D (61)**.

The potential rating shows the effect of undertaking all of the improvement measures listed within your recommendations report.
