# Home Report

14 Clayhills Drive  
Dundee DD2 1SX

# Single Survey

## Survey report on:

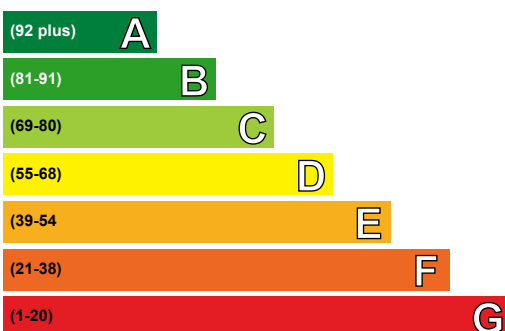
Very energy efficient - lower running costs

Not energy efficient - higher running costs
