Home Report

Single Survey

Property address	D/L 40 Glebe Road Kilmarnock KA1 3DL
Customer	The late William B Mathewson
Customer address	D/L 40 Glebe Road Kilmarnock KA1 3DL
Prepared by	Shepherd Chartered Surveyors
Date of inspection	25/06/2026

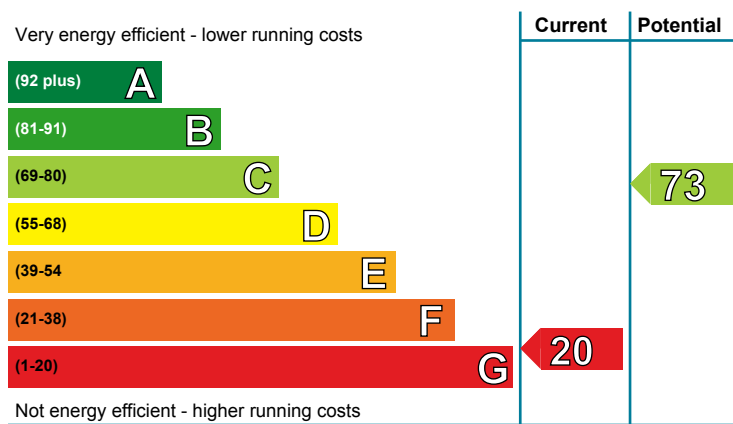
Energy Efficiency Rating

This graph shows the current efficiency of your home, taking into account both energy efficiency and fuel costs. The higher this rating, the lower your fuel bills are likely to be.

Your current rating is **band G (20)**. The average rating for EPCs in Scotland is **band D (61)**.

The potential rating shows the effect of undertaking all of the improvement measures listed within your recommendations report.

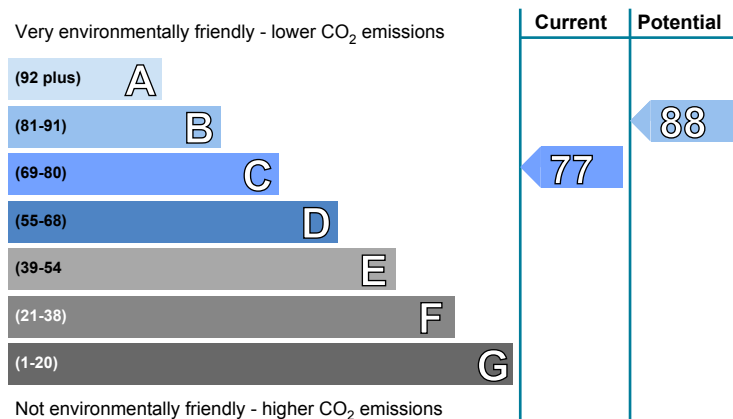
Environmental Impact (CO₂) Rating

This graph shows the effect of your home on the environment in terms of carbon dioxide (CO₂) emissions. The higher the rating, the less impact it has on the environment.
