# Home Report

# Scottish Single Survey

# Single Survey

| Property address | 6 Manse Street<br>Tain<br>IV19 1AN |

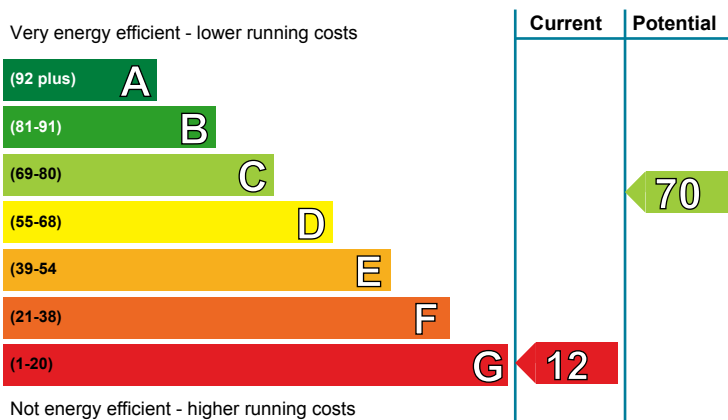
## Energy Efficiency Rating

This graph shows the current efficiency of your home, taking into account both energy efficiency and fuel costs. The higher this rating, the lower your fuel bills are likely to be.

Your current rating is **band G (12)**. The average rating for EPCs in Scotland is **band D (61)**.

The potential rating shows the effect of undertaking all of the improvement measures listed within your recommendations report.
