YOUR ONESURVEY
HOME REPORT

8 Green Road
Kinross
KY13 8TT

Single Survey

Surveyor Reference	DD3381
Executry Of	Mr. Allan Davidson
Selling address	8 Green Road Kinross KY13 8TT
Date of Inspection	08/04/2026
Prepared by	Peter Bennet, MRICS Dunfermline - Allied Surveyors Scotland Ltd

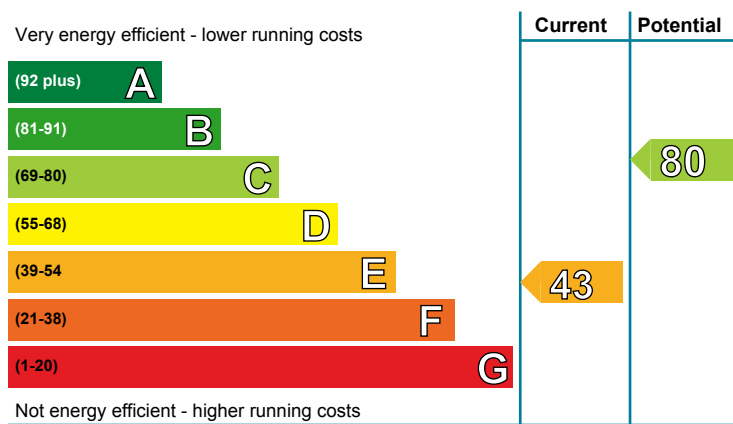
Energy Efficiency Rating

This graph shows the current efficiency of your home, taking into account both energy efficiency and fuel costs. The higher this rating, the lower your fuel bills are likely to be.

Your current rating is **band E (43)**. The average rating for EPCs in Scotland is **band D (61)**.

The potential rating shows the effect of undertaking all of the improvement measures listed within your recommendations report.

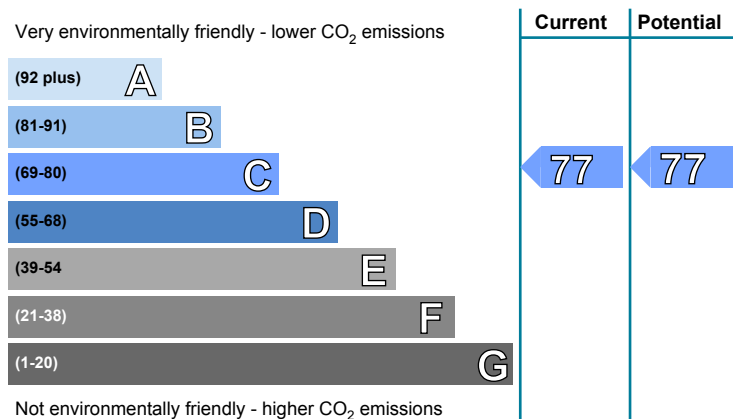
Environmental Impact (CO₂) Rating

This graph shows the effect of your home on the environment in terms of carbon dioxide (CO₂) emissions. The higher the rating, the less impact it has on the environment.
