home report

MossideFarmhouse

**Ellon
AB41 8DU**

Energy Performance Certificate (EPC)

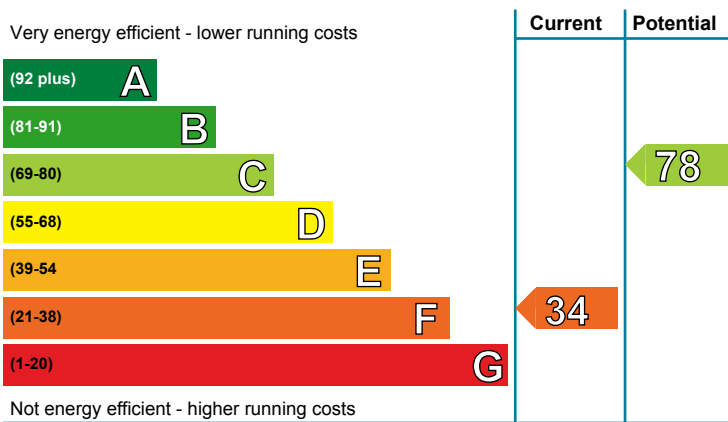
Energy Efficiency Rating

This graph shows the current efficiency of your home, taking into account both energy efficiency and fuel costs. The higher this rating, the lower your fuel bills are likely to be.

Your current rating is **band F (34)**. The average rating for EPCs in Scotland is **band D (61)**.

The potential rating shows the effect of undertaking all of the improvement measures listed within your recommendations report.
