# Home Report

94 Midton Road  
Ayr KA7 2TP

# Single Survey

| <b>Description</b> | The subjects comprise a single storey end terrace cottage forming a part of a substantial converted detached house. |

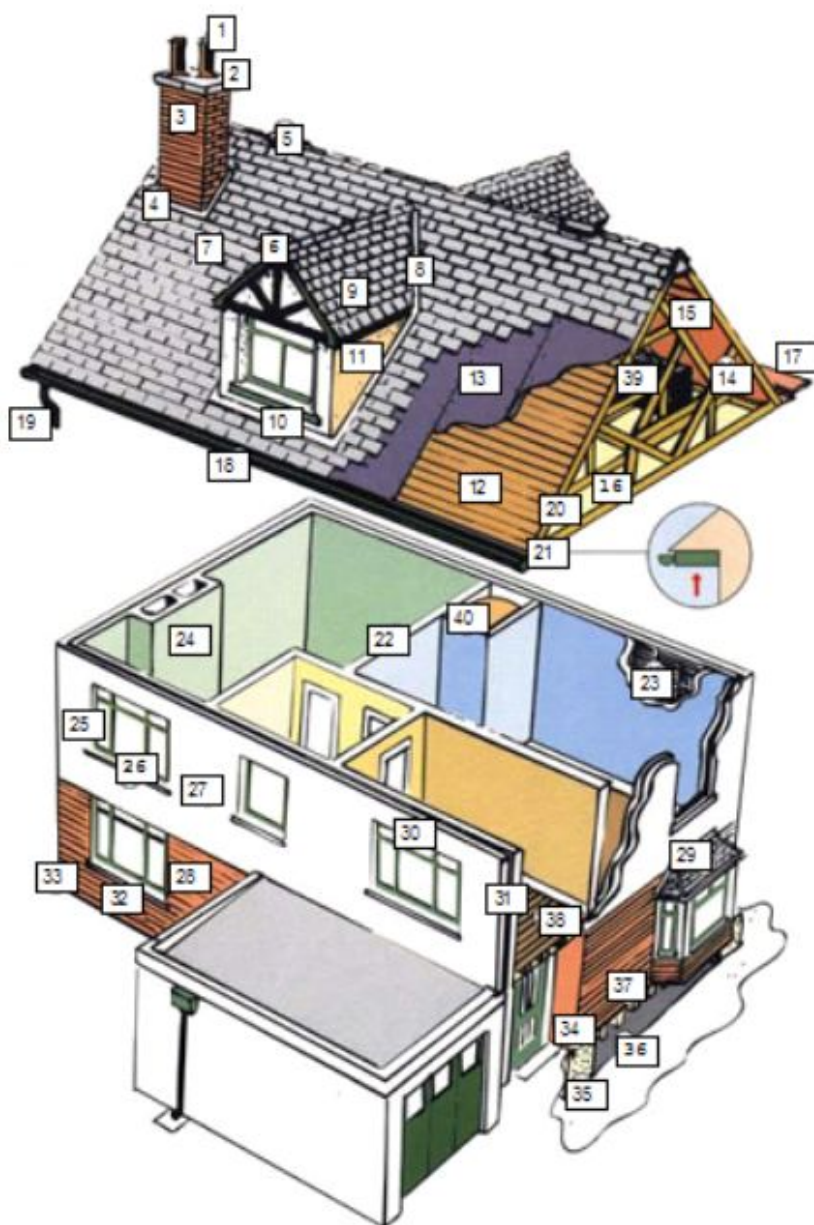
## Sectional diagram showing elements of a typical house

| 1 | Chimney pots |
| 2 | Coping stone |
| 35 | Foundations |
