Home Report

14 Dollar Gardens,
Falkirk,
FK2 7LG

Single Survey

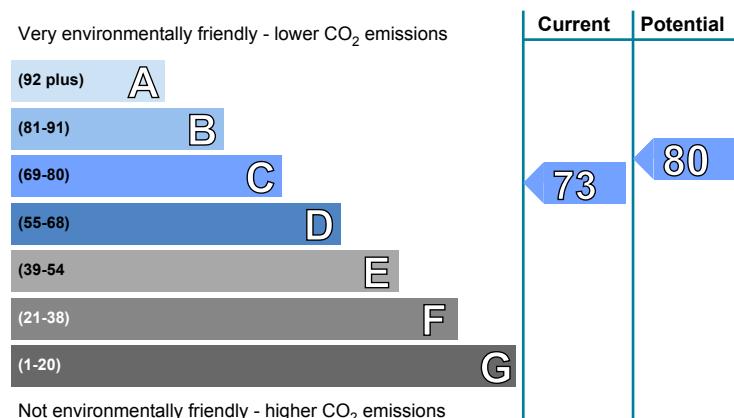
Environmental Impact (CO₂) Rating

This graph shows the effect of your home on the environment in terms of carbon dioxide (CO₂) emissions. The higher the rating, the less impact it has on the environment.
