Home Report

3 East Grange of Conon Farm Cottage
Arbroath DD11 3SF

Single Survey

Property Address	3 East Grange of Conon Farm Cottage Arbroath DD11 3SF
Customer	Ms S Marchand & Mr S Spatzek
Prepared by	Graham + Sibbald Property Consultants Limited
Date of Inspection	08/06/2026

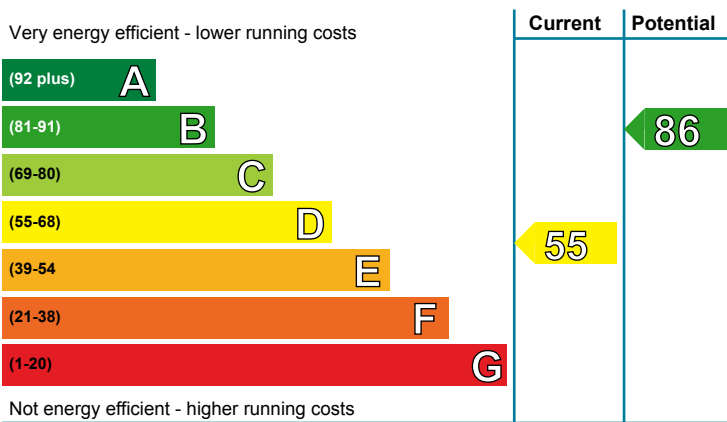
Energy Efficiency Rating

This graph shows the current efficiency of your home, taking into account both energy efficiency and fuel costs. The higher this rating, the lower your fuel bills are likely to be.

Your current rating is **band D (55)**. The average rating for EPCs in Scotland is **band D (61)**.

The potential rating shows the effect of undertaking all of the improvement measures listed within your recommendations report.

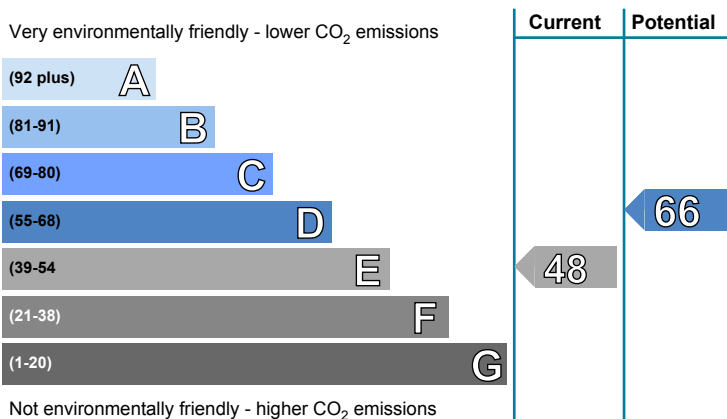
Environmental Impact (CO₂) Rating

This graph shows the effect of your home on the environment in terms of carbon dioxide (CO₂) emissions. The higher the rating, the less impact it has on the environment.
