YOUR ONESURVEY
HOME REPORT

12 Cedar Crescent
Whitburn
Bathgate
EH47 8LN

SINGLE SURVEY

A report on the condition of the property, with categories being rated from 1 to 3.

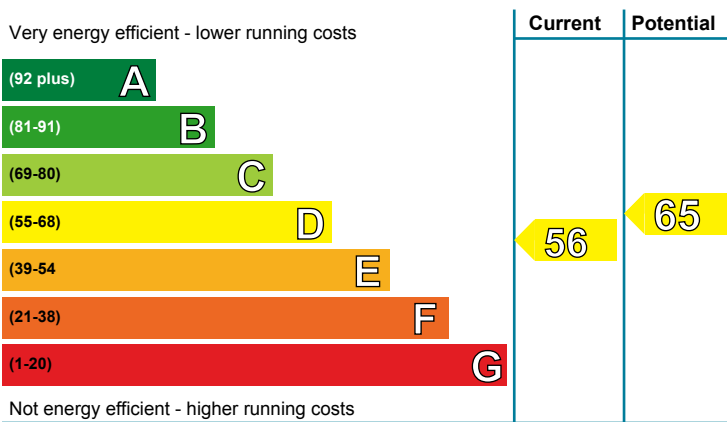
Energy Efficiency Rating

This graph shows the current efficiency of your home, taking into account both energy efficiency and fuel costs. The higher this rating, the lower your fuel bills are likely to be.

Your current rating is **band D (56)**. The average rating for EPCs in Scotland is **band D (61)**.

The potential rating shows the effect of undertaking all of the improvement measures listed within your recommendations report.

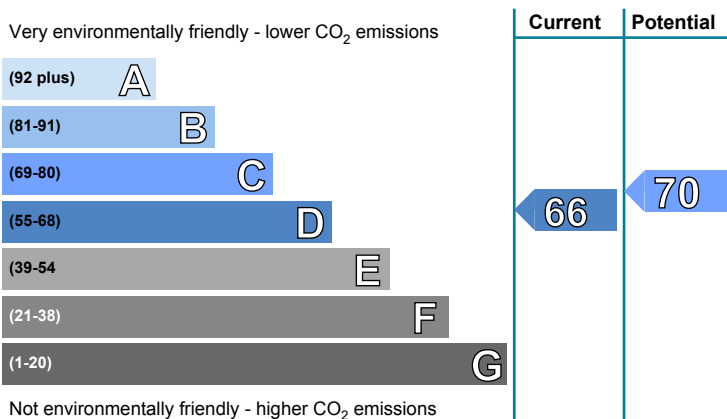
Environmental Impact (CO₂) Rating

This graph shows the effect of your home on the environment in terms of carbon dioxide (CO₂) emissions. The higher the rating, the less impact it has on the environment.
