19 Ranfurly Drive,
Cumbernauld,
G68 0DR

Home Report

Single Survey

| Property Address | 19 Ranfurly Drive, Cumbernauld, G68 0DR |

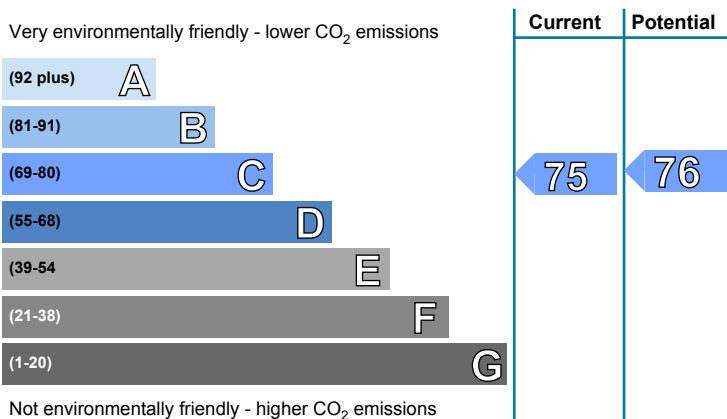
Environmental Impact (CO₂) Rating

This graph shows the effect of your home on the environment in terms of carbon dioxide (CO₂) emissions. The higher the rating, the less impact it has on the environment.
