# Home Report

# Single Survey

<b>Property address</b>	8 Rosebank Gardens Largs KA30 8TD
-------------------------	---

<b>Date of inspection</b>	10/04/2026
---------------------------	------------

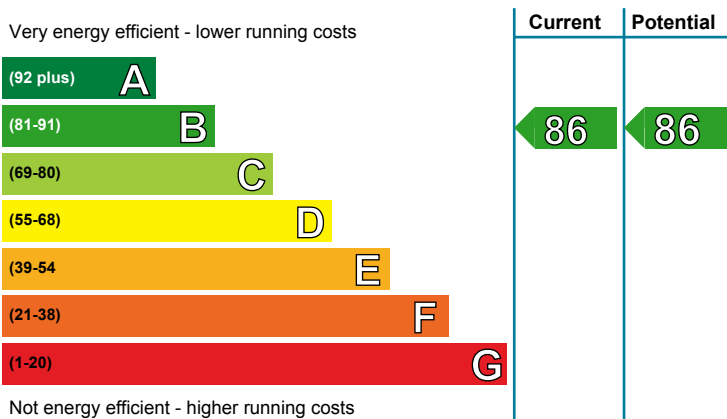
## Energy Efficiency Rating

This graph shows the current efficiency of your home, taking into account both energy efficiency and fuel costs. The higher this rating, the lower your fuel bills are likely to be.

Your current rating is **band B (86)**. The average rating for EPCs in Scotland is **band D (61)**.

The potential rating shows the effect of undertaking all of the improvement measures listed within your recommendations report.
