# Home Report

# Single Survey

<b>Property address</b>	6 Tochieneal Corner Lintmill Buckie AB56 4XR
<b>Customer</b>	
<b>Customer address</b>	6 Tochieneal Corner Lintmill Buckie AB56 4XR
<b>Prepared by</b>	Shepherd Chartered Surveyors
<b>Date of inspection</b>	07/04/2026

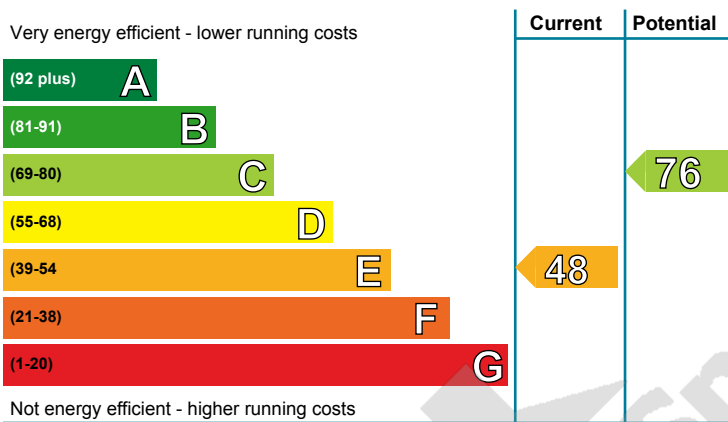
## Energy Efficiency Rating

This graph shows the current efficiency of your home, taking into account both energy efficiency and fuel costs. The higher this rating, the lower your fuel bills are likely to be.

Your current rating is **band E (48)**. The average rating for EPCs in Scotland is **band D (61)**.

The potential rating shows the effect of undertaking all of the improvement measures listed within your recommendations report.

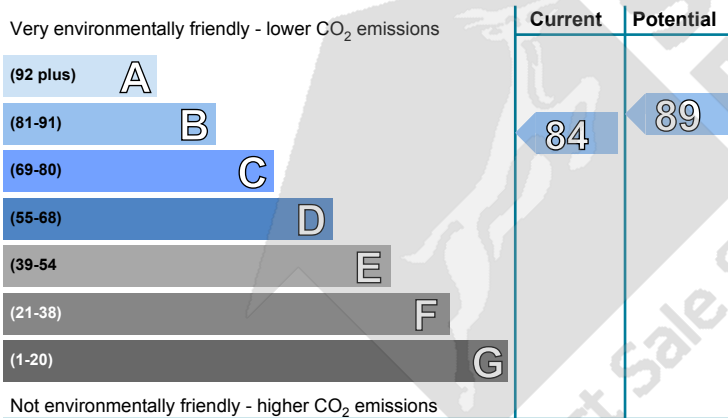
## Environmental Impact (CO<sub>2</sub>) Rating

This graph shows the effect of your home on the environment in terms of carbon dioxide (CO<sub>2</sub>) emissions. The higher the rating, the less impact it has on the environment.
