# Home Report

# Single Survey

| Property address | 48 South Hermitage Street<br>Newcastleton<br>TD9 0QE |
| Prepared by | Shepherd Chartered Surveyors |

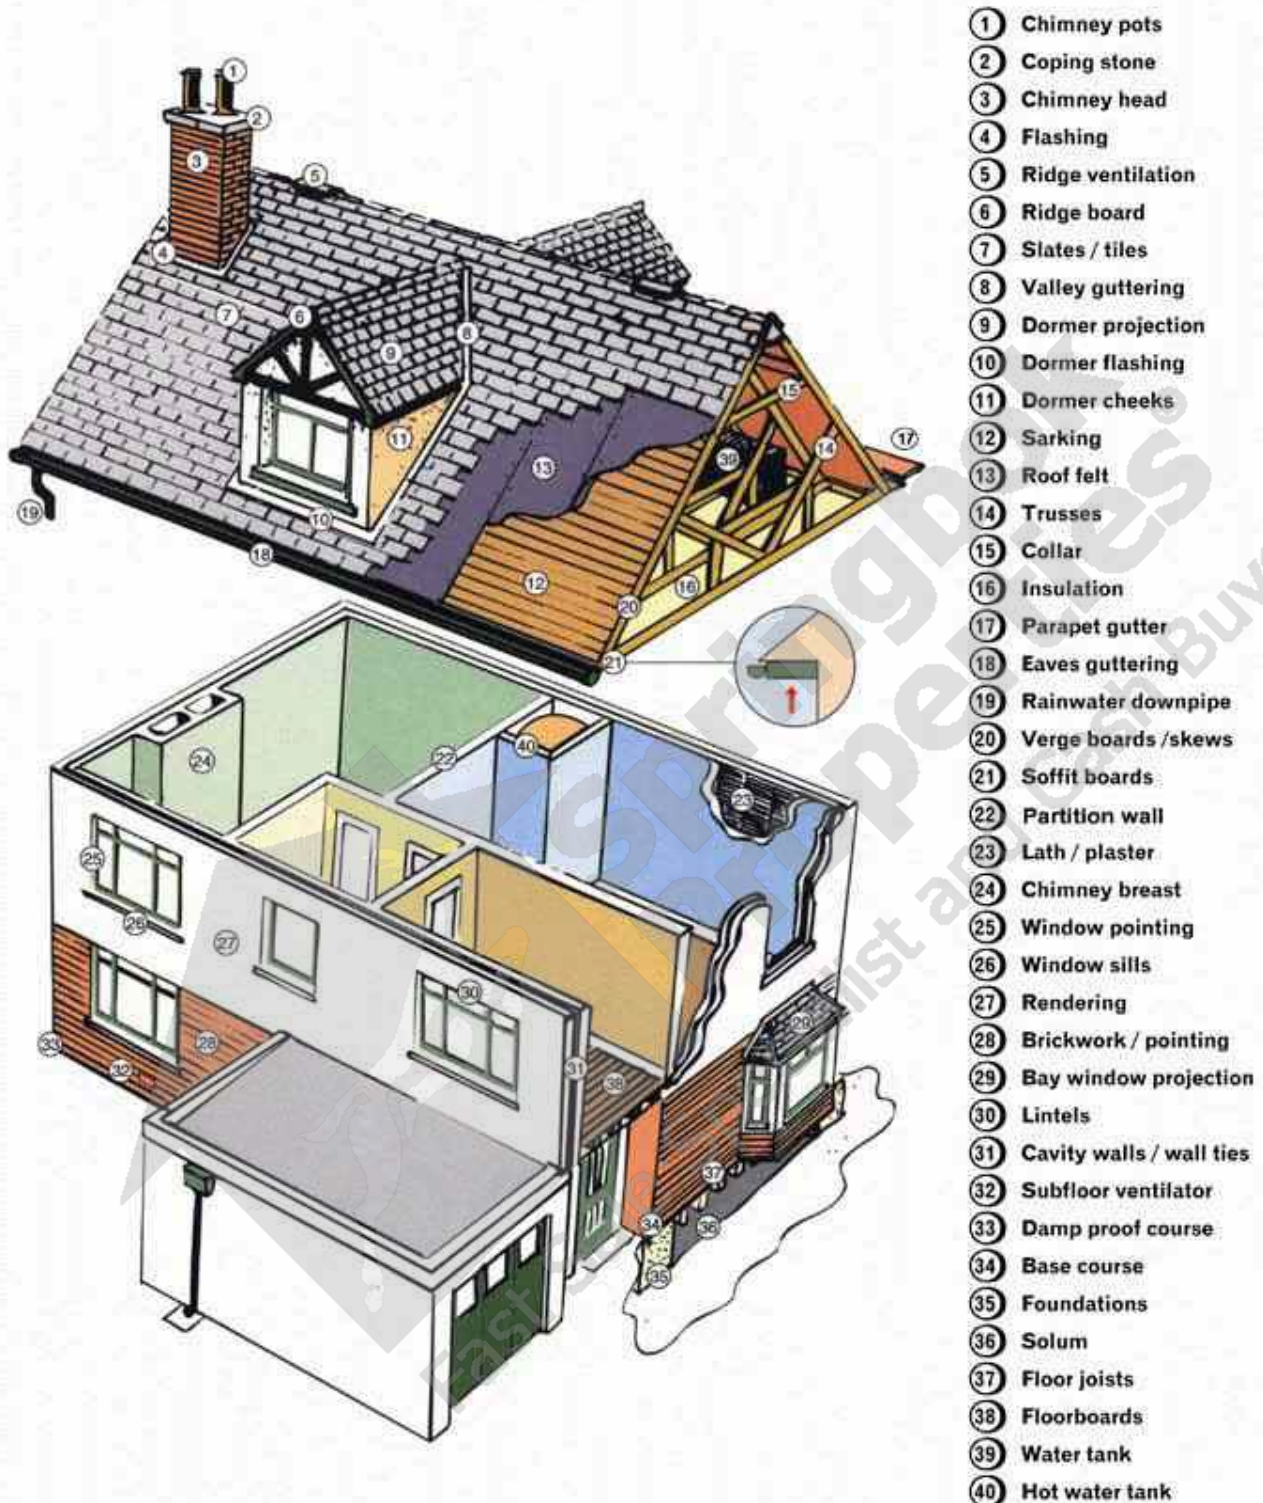
## Sectional Diagram showing elements of a typical house

Reference may be made in this report to some or all of the above component parts of the property. This diagram may assist you in locating and understanding these items.
