17 Balfroon Drive,  
COATBRIDGE,  
ML5 4FF

# Home Report

# Single Survey

<b>Property Address</b>	17 Balfroon Drive, COATBRIDGE, ML5 4FF
<b>Reference</b>	1578249
<b>Customer Name</b>	Rachael Edgar
<b>Date of Inspection</b>	13th May 2026
<b>Surveyor's name, qualifications and office</b>	Kenneth Geddes BSc (Hons) MRICS  DM Hall LLP Chartered Surveyors Unit 3, Cadzow Park 82 Muir Street Hamilton ML3 6BJ  Tel: 01698 284939  email: hamiltonresidential@dmhall.co.uk
<b>Prepared By</b>	DM Hall LLP

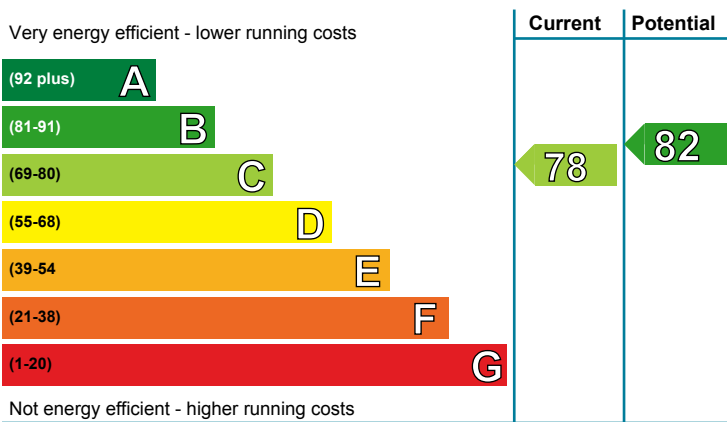
## Energy Efficiency Rating

This graph shows the current efficiency of your home, taking into account both energy efficiency and fuel costs. The higher this rating, the lower your fuel bills are likely to be.

Your current rating is **band C (78)**. The average rating for EPCs in Scotland is **band D (61)**.

The potential rating shows the effect of undertaking all of the improvement measures listed within your recommendations report.

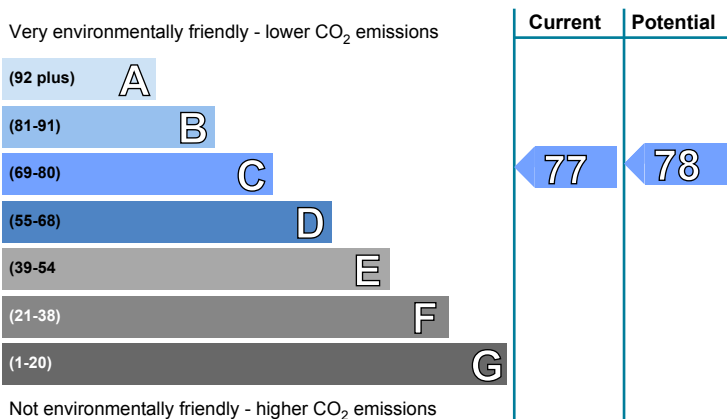
## Environmental Impact (CO<sub>2</sub>) Rating

This graph shows the effect of your home on the environment in terms of carbon dioxide (CO<sub>2</sub>) emissions. The higher the rating, the less impact it has on the environment.
