## Home Report

Faery Fort Camusluinie

Near Kyle of Lochalsh  
IV40 8EA

## Energy Performance Certificate

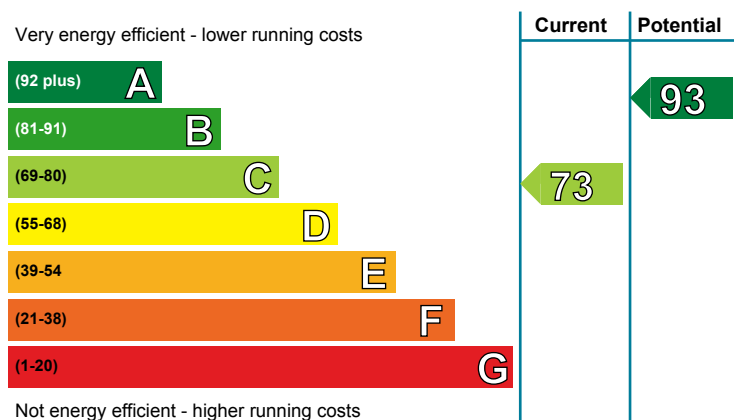
## Energy Efficiency Rating

This graph shows the current efficiency of your home, taking into account both energy efficiency and fuel costs. The higher this rating, the lower your fuel bills are likely to be.

Your current rating is **band C (73)**. The average rating for EPCs in Scotland is **band D (61)**.

The potential rating shows the effect of undertaking all of the improvement measures listed within your recommendations report.

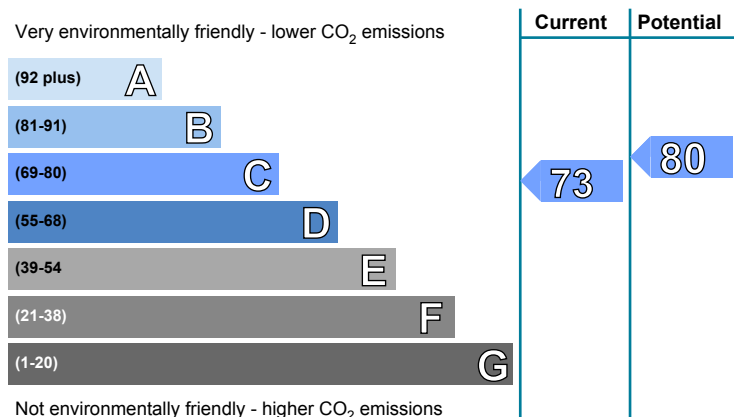
## Environmental Impact (CO<sub>2</sub>) Rating

This graph shows the effect of your home on the environment in terms of carbon dioxide (CO<sub>2</sub>) emissions. The higher the rating, the less impact it has on the environment.

Your current rating is **band C (73)**

The potential rating shows the effect of undertaking all of the improvement measures listed within your recommendations report.
