# Home Report

# Scottish Single Survey

| Property address | 24 Hardie Court<br>Aberchirder<br>Huntly<br>AB54 7TG |
| Prepared by | Shepherd Chartered Surveyors |

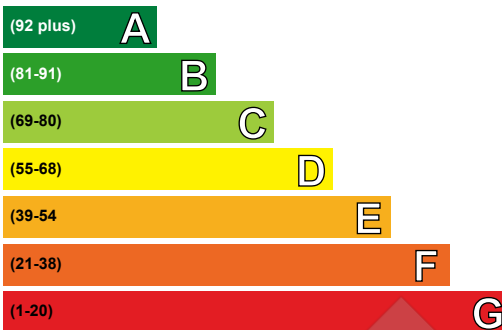
\* based upon the cost of energy for heating, hot water, lighting and ventilation, calculated using standard assumptions

Very energy efficient - lower running costs

Not energy efficient - higher running costs

The potential rating shows the effect of undertaking all of the improvement measures listed within your recommendations report.

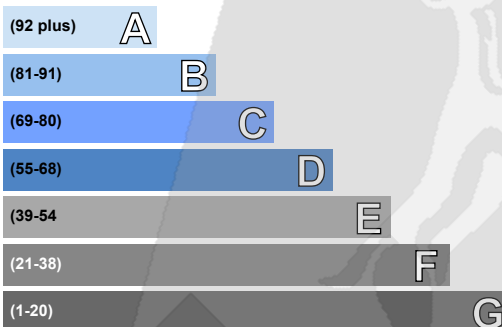
Very environmentally friendly - lower CO<sub>2</sub> emissions

Not environmentally friendly - higher CO<sub>2</sub> emissions
