## Home Report

26 CAMORE CRESCENT  
DORNOCH  
IV25 3HU

26 CAMORE CRESCENT, DORNOCH, IV25 3HU

**Dwelling type:** Semi-detached house  
**Date of assessment:** 11 February 2026  
**Date of certificate:** 16 February 2026  
**Total floor area:** 98 m<sup>2</sup>  
**Primary Energy Indicator:** 366 kWh/m<sup>2</sup>/year

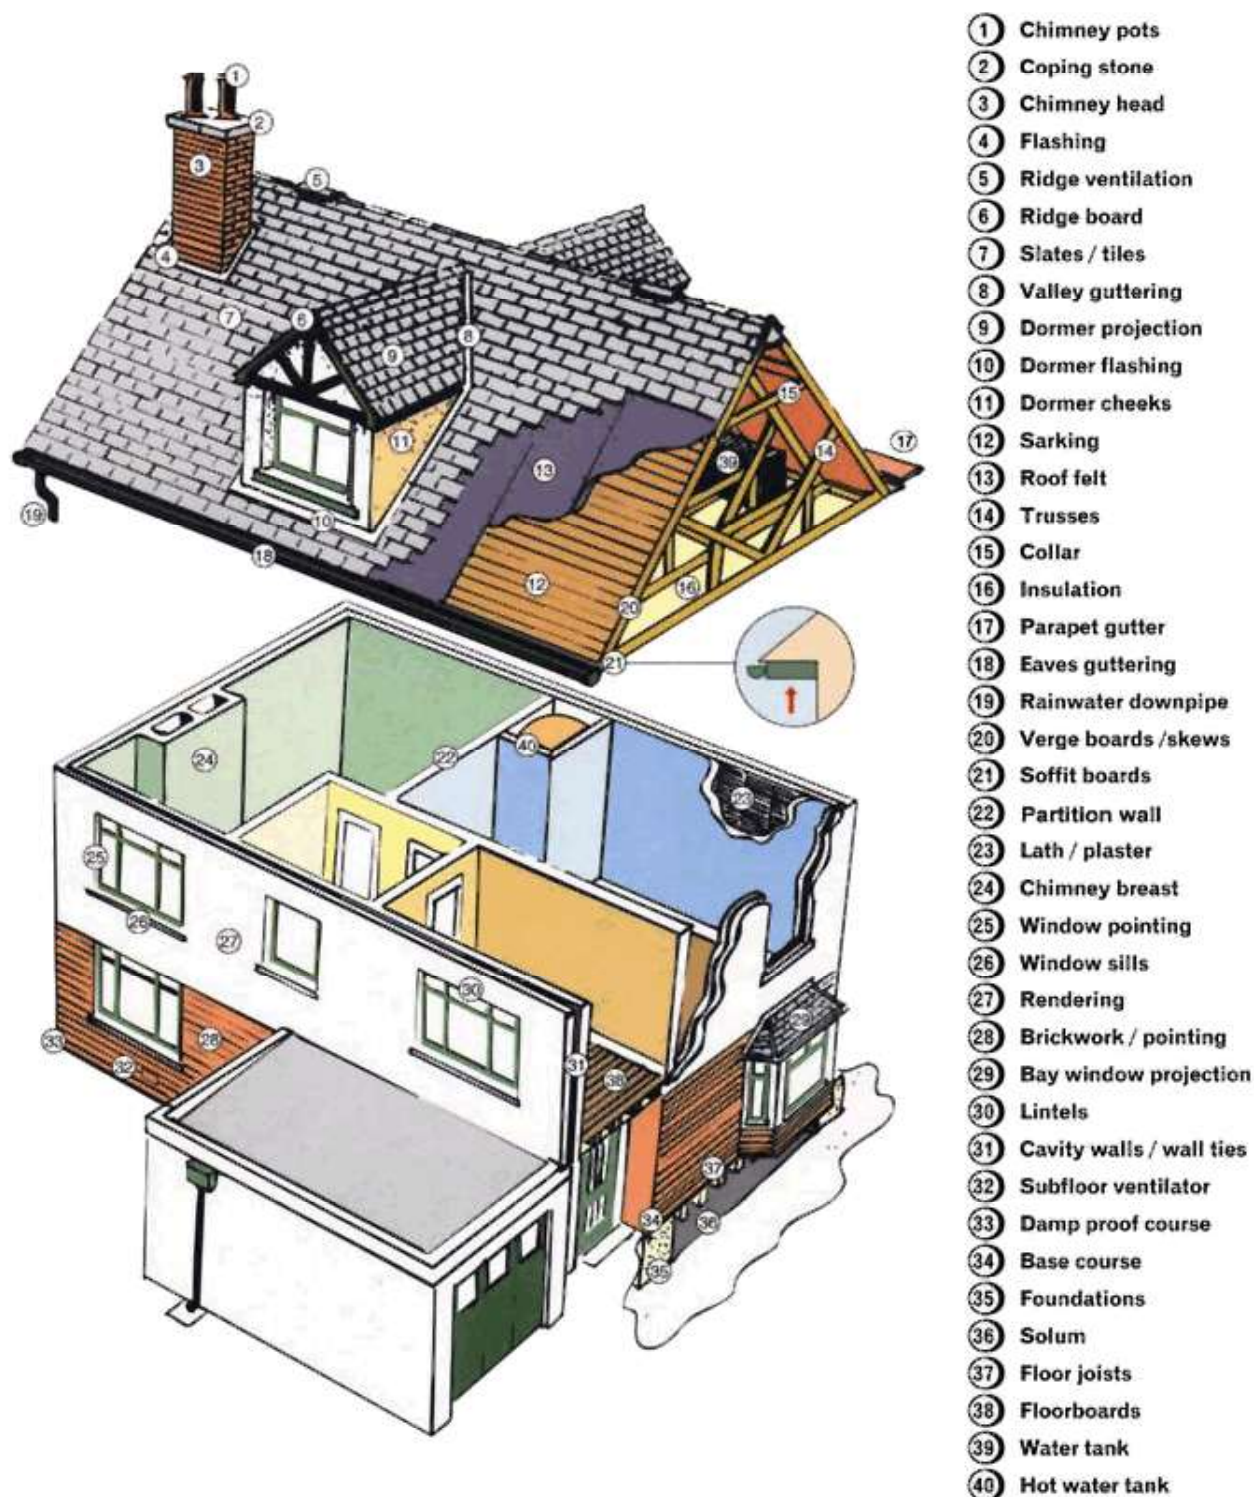
## Sectional Diagram showing elements of a typical house

Reference may be made in this report to some or all of the above component parts of the property. This diagram may assist you in locating and understanding these items.
