# home report

**LETTERSHUNA LODGE**

**APPIN  
PA38 4BN**

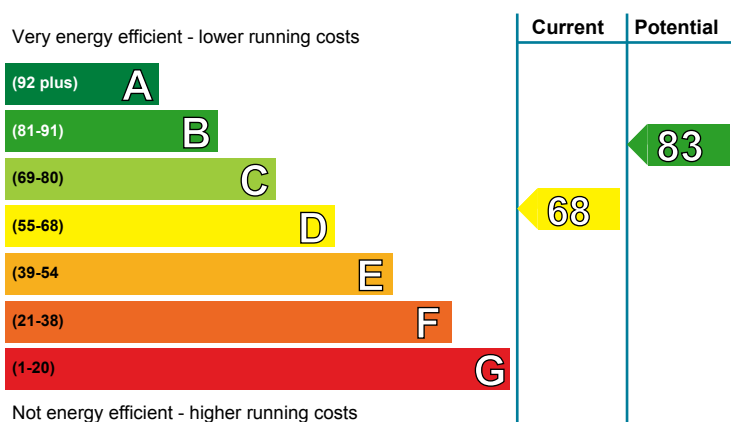
## Energy Efficiency Rating

This graph shows the current efficiency of your home, taking into account both energy efficiency and fuel costs. The higher this rating, the lower your fuel bills are likely to be.

Your current rating is **band D (68)**. The average rating for EPCs in Scotland is **band D (61)**.

The potential rating shows the effect of undertaking all of the improvement measures listed within your recommendations report.

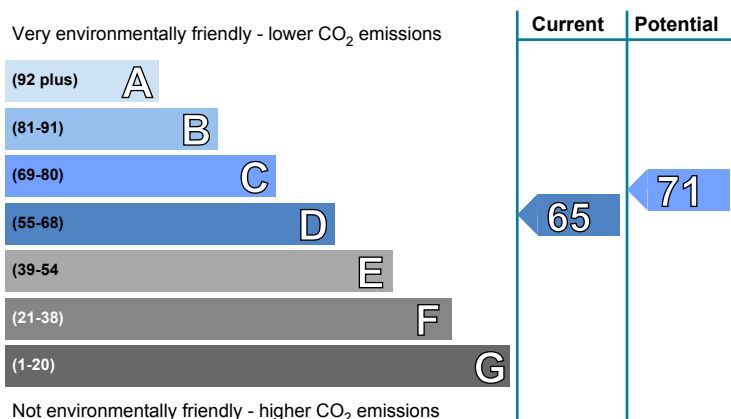
## Environmental Impact (CO<sub>2</sub>) Rating

This graph shows the effect of your home on the environment in terms of carbon dioxide (CO<sub>2</sub>) emissions. The higher the rating, the less impact it has on the environment.

Your current rating is **band D (65)**

The potential rating shows the effect of undertaking all of the improvement measures listed within your recommendations report.
