YOUR ONESURVEY
HOME REPORT

Nineveh Bank
Woodville
Arbroath
DD11 2QW

SINGLE SURVEY

Single Survey

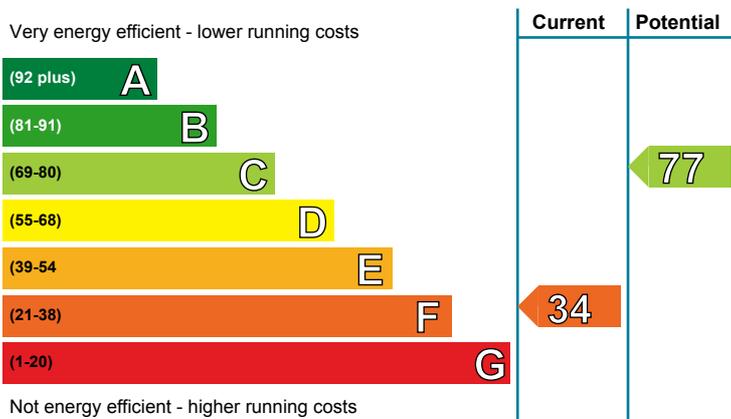
Energy Efficiency Rating

This graph shows the current efficiency of your home, taking into account both energy efficiency and fuel costs. The higher this rating, the lower your fuel bills are likely to be.

Your current rating is **band F (34)**. The average rating for EPCs in Scotland is **band D (61)**.

The potential rating shows the effect of undertaking all of the improvement measures listed within your recommendations report.

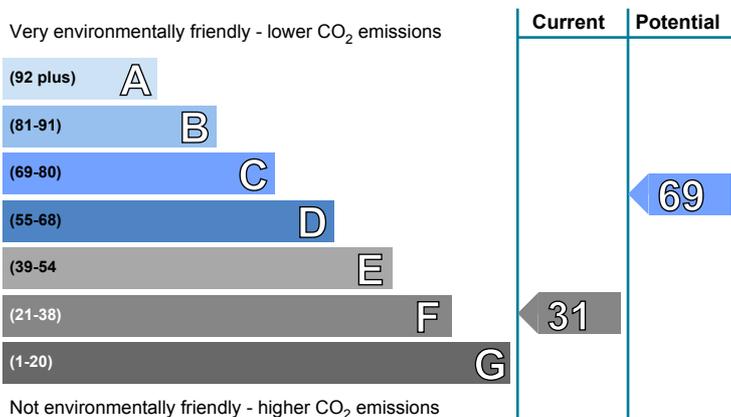
Environmental Impact (CO₂) Rating

This graph shows the effect of your home on the environment in terms of carbon dioxide (CO₂) emissions. The higher the rating, the less impact it has on the environment.
