# Home Report V1/02/2025

**DM Hall LLP**  
17 Corstorphine Road  
Edinburgh  
United Kingdom  
EH12 6DD

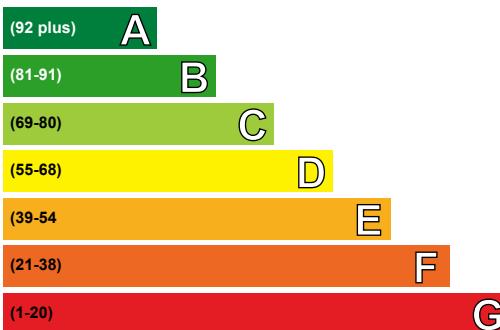
Very energy efficient - lower running costs

Current Potential

81 81

The potential rating shows the effect of undertaking all of the improvement measures listed within your recommendations report.

Not energy efficient - higher running costs

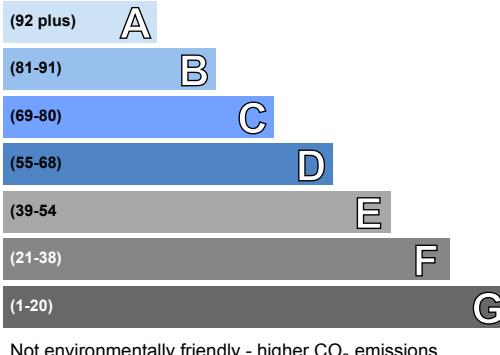
Very environmentally friendly - lower CO<sub>2</sub> emissions

Current Potential

85 85

The potential rating shows the effect of undertaking all of the improvement measures listed within your recommendations report.
