# Home Report

# Single Survey

## Survey Report on:

| <b>Property Address</b> | Flat 3,<br>211,<br>Corbiehall,<br>BO'NESS,<br>EH51 0AX |

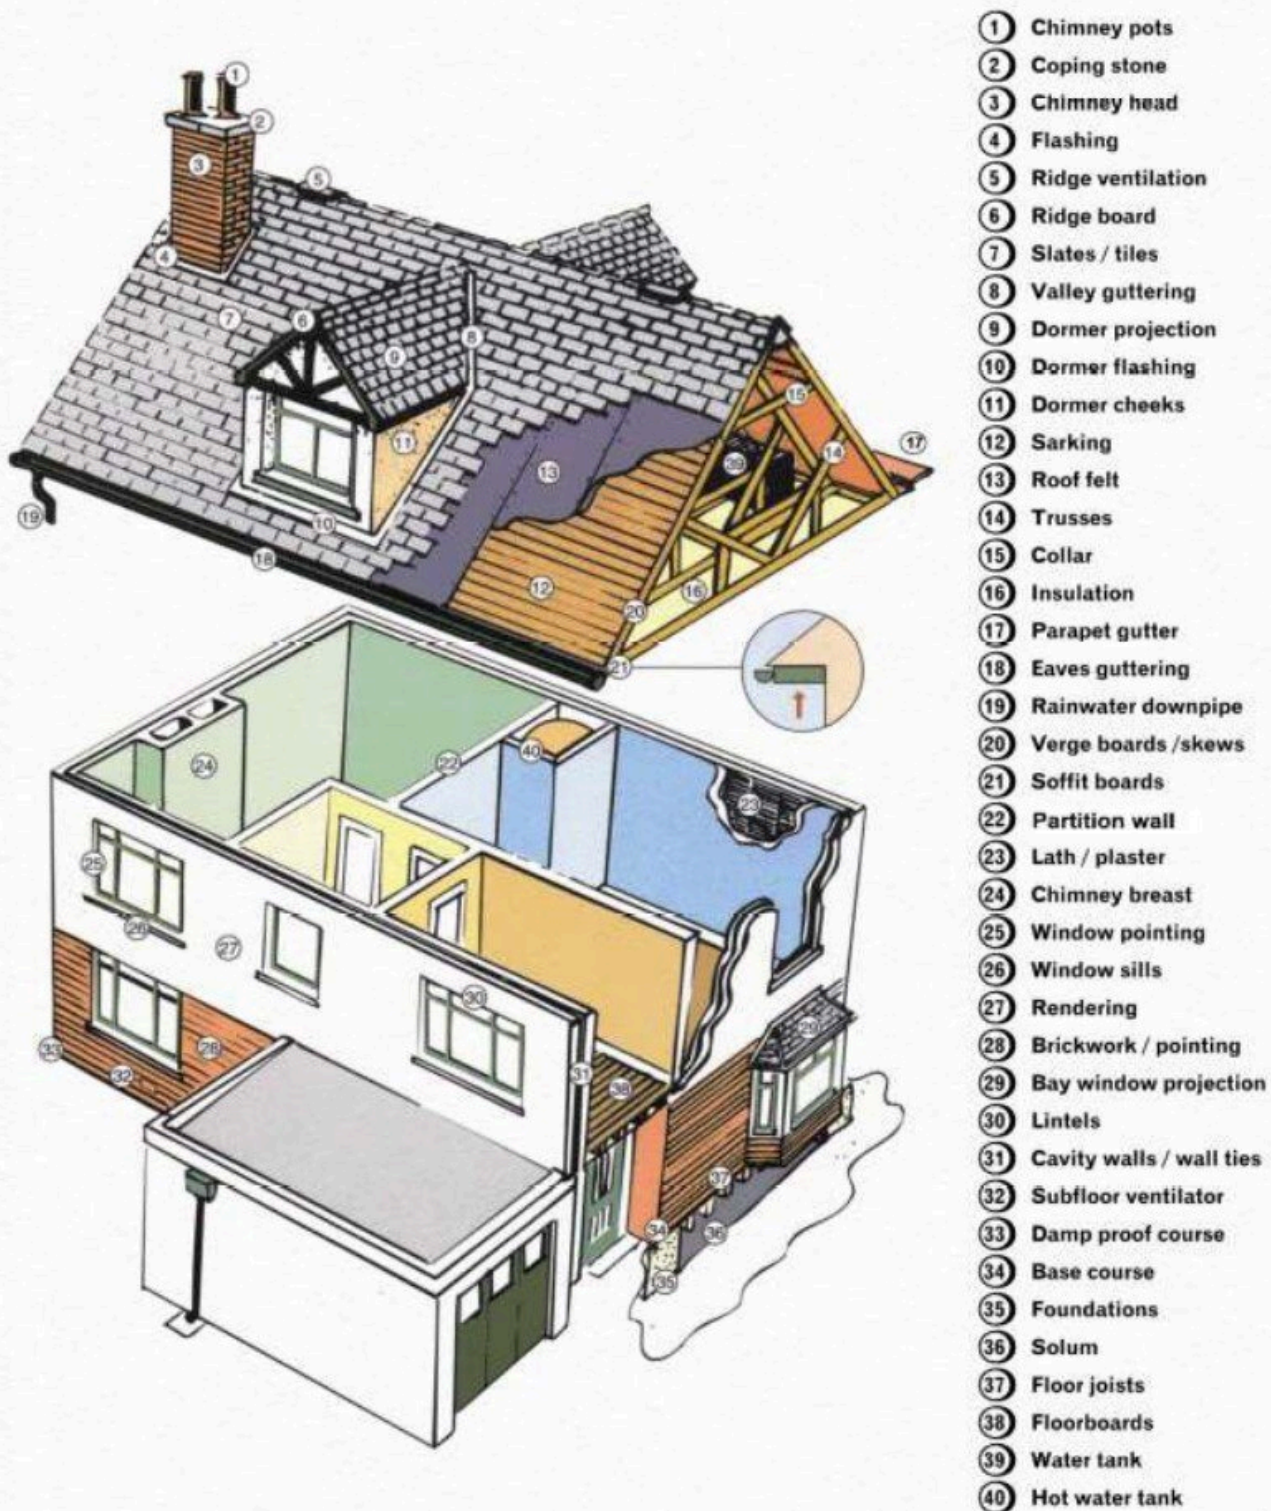
## Sectional Diagram showing elements of a typical house

Reference may be made in this report to some or all of the above component parts of the property. This diagram may assist you in locating and understanding these items.
