# Home Report

41 Main Street,  
Dalry,  
CASTLE DOUGLAS,  
DG7 3UP

# Single Survey

## Survey Report on:

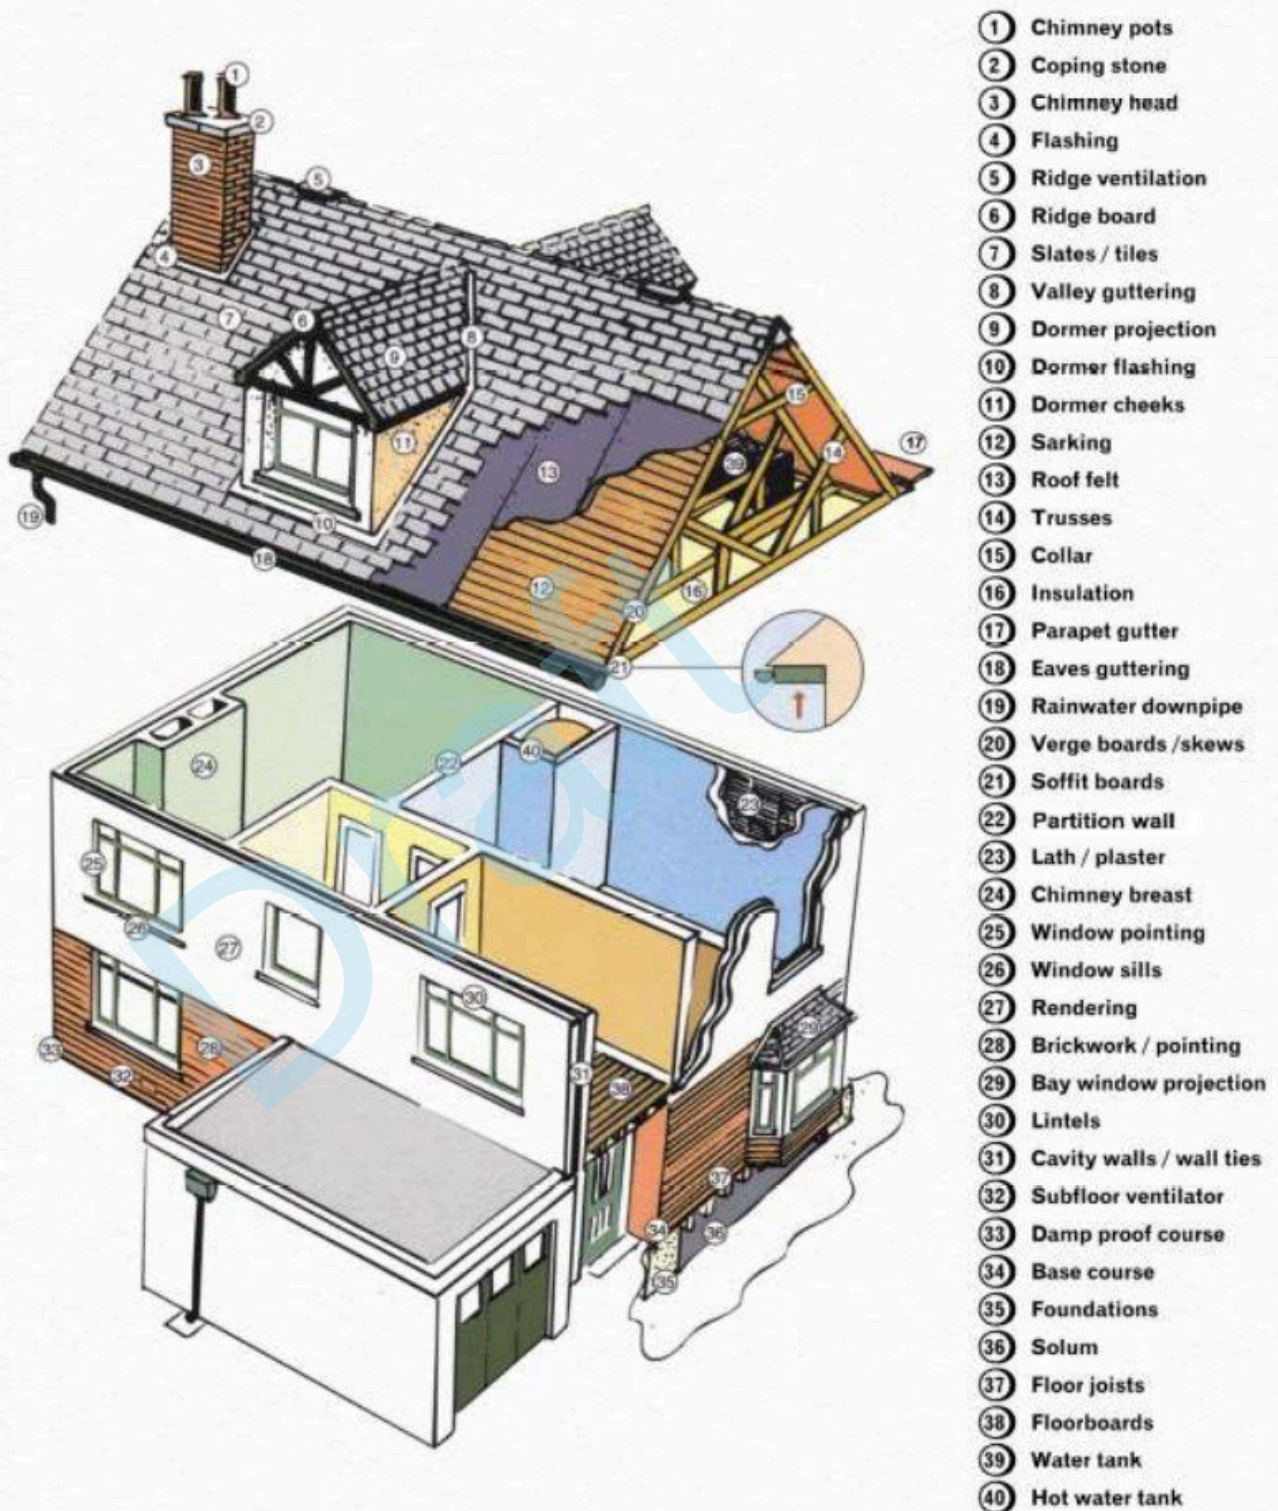
## Sectional Diagram showing elements of a typical house

Reference may be made in this report to some or all of the above component parts of the property. This diagram may assist you in locating and understanding these items.
