# Home Report

# Scottish Single Survey

# Single Survey

| <b>Property address</b> | Drumlochy<br>Letterfinlay<br>Spean Bridge<br>PH34 4DZ |

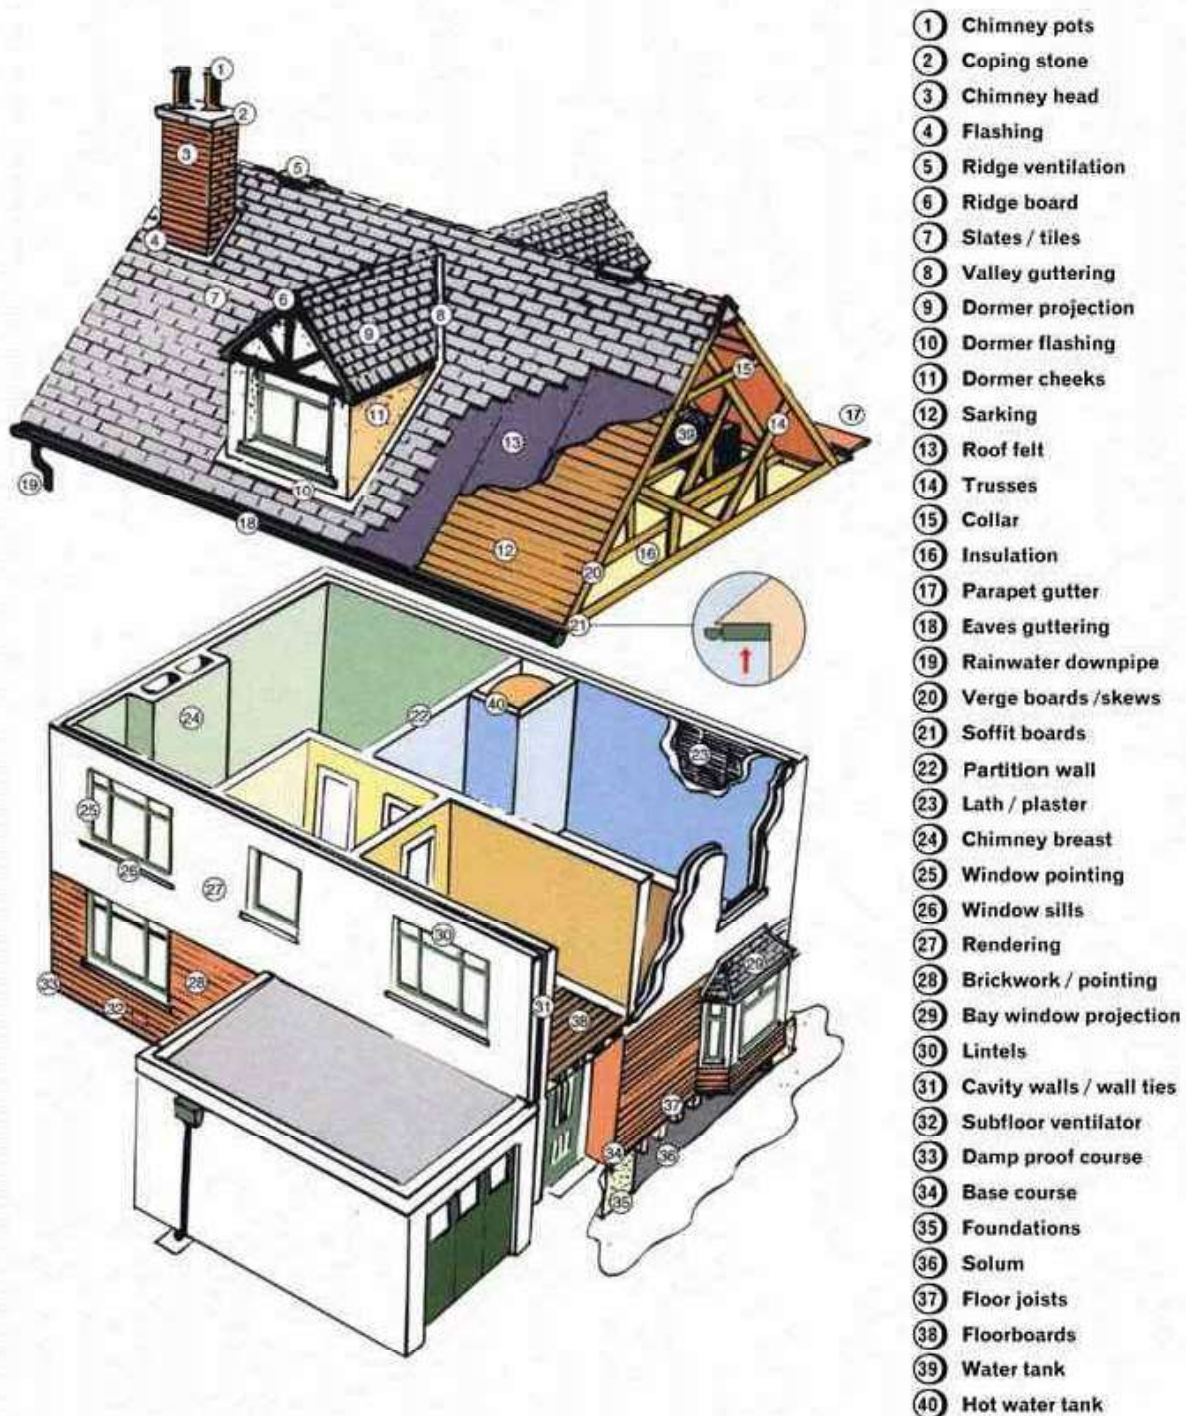
## Sectional Diagram showing elements of a typical house

Reference may be made in this report to some or all of the above component parts of the property. This diagram may assist you in locating and understanding these items.

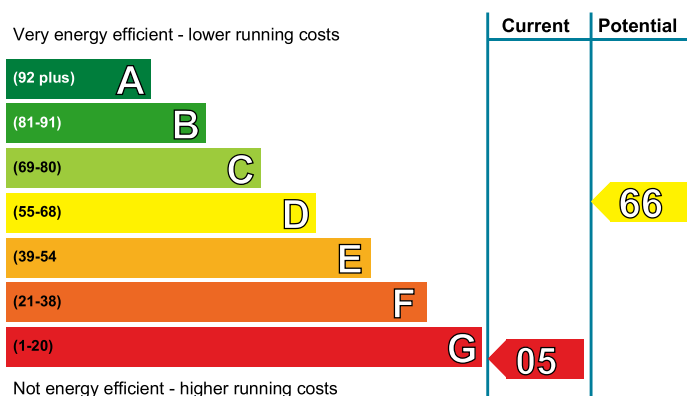
## Energy Efficiency Rating

This graph shows the current efficiency of your home, taking into account both energy efficiency and fuel costs. The higher this rating, the lower your fuel bills are likely to be.

Your current rating is **band G (5)**. The average rating for EPCs in Scotland is **band D (61)**.

The potential rating shows the effect of undertaking all of the improvement measures listed within your recommendations report.

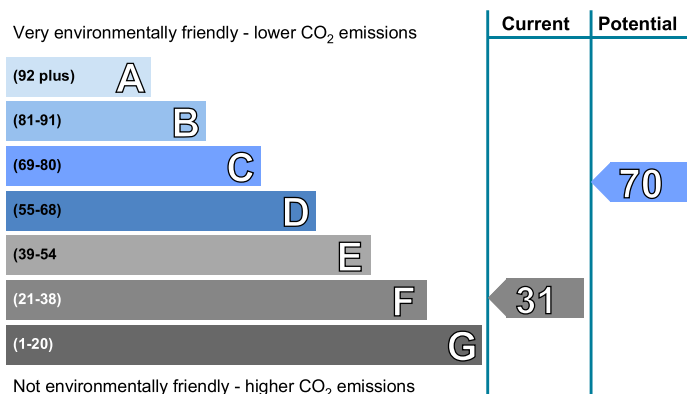
## Environmental Impact (CO<sub>2</sub>) Rating

This graph shows the effect of your home on the environment in terms of carbon dioxide (CO<sub>2</sub>) emissions. The higher the rating, the less impact it has on the environment.
