# Home Report

Claveron,  
Lamlash,  
Isle of Arran,  
KA27 8NB

# Single Survey

## Survey Report on:

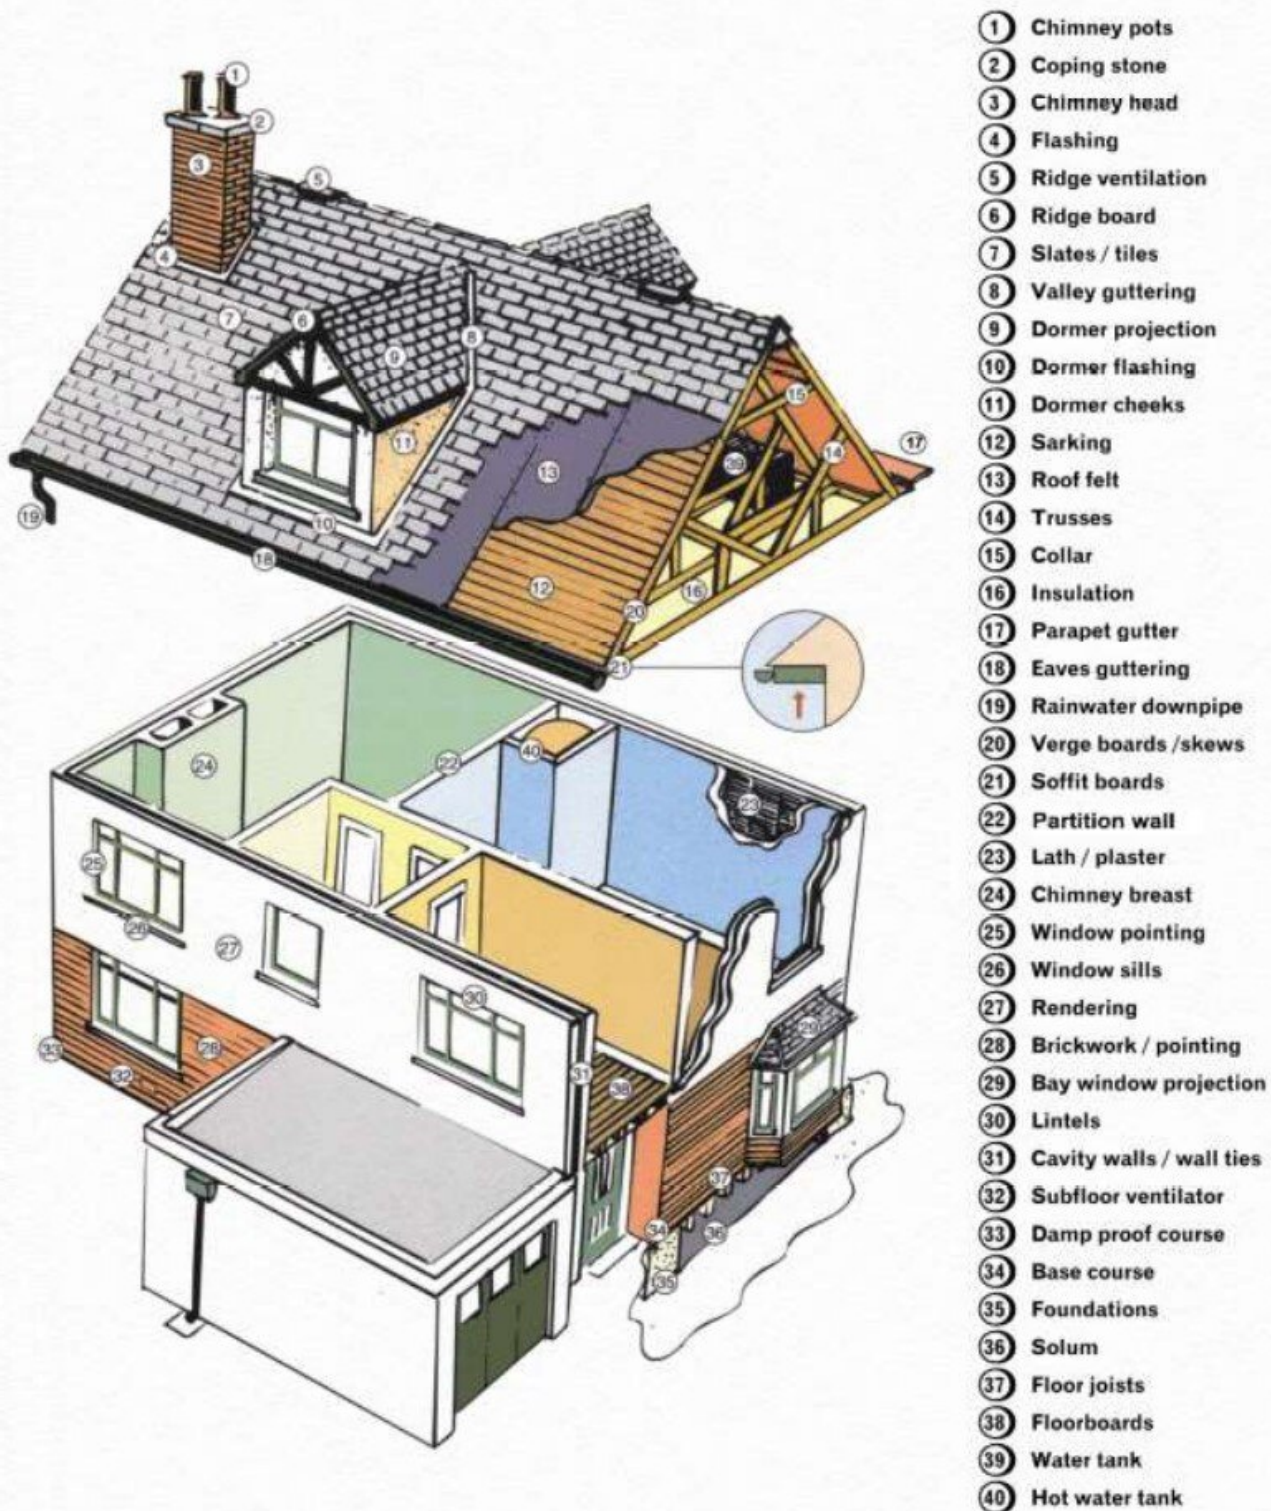
## Sectional Diagram showing elements of a typical house

Reference may be made in this report to some or all of the above component parts of the property. This diagram may assist you in locating and understanding these items.
