# Home Report

# Single Survey

<b>Property address</b>	20 Standalane Stewarton Kilmarnock KA3 3AW
<b>Customer</b>	Mr & Mrs M White
<b>Customer address</b>	20 Standalane Stewarton Kilmarnock KA3 3AW
<b>Prepared by</b>	Shepherd Chartered Surveyors
<b>Date of inspection</b>	13/04/2026

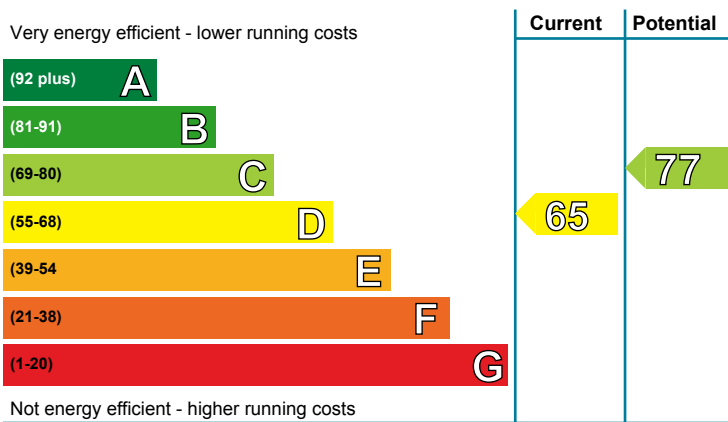
## Energy Efficiency Rating

This graph shows the current efficiency of your home, taking into account both energy efficiency and fuel costs. The higher this rating, the lower your fuel bills are likely to be.

Your current rating is **band D (65)**. The average rating for EPCs in Scotland is **band D (61)**.

The potential rating shows the effect of undertaking all of the improvement measures listed within your recommendations report.

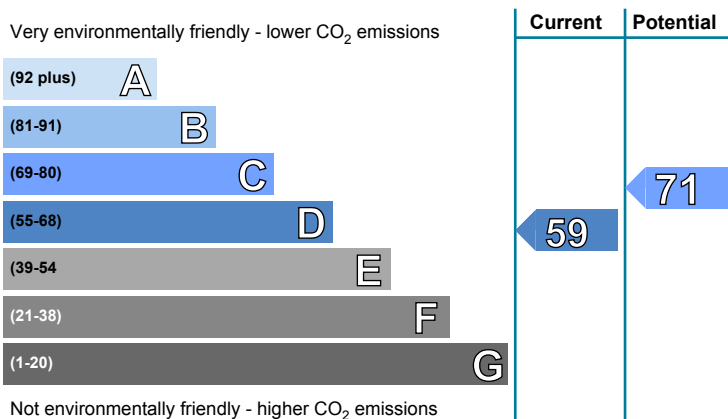
## Environmental Impact (CO<sub>2</sub>) Rating

This graph shows the effect of your home on the environment in terms of carbon dioxide (CO<sub>2</sub>) emissions. The higher the rating, the less impact it has on the environment.
