# home report

**JACKSTON OF MELROSE GAMRIE**

**BANFF  
AB45 3SA**

# Energy Performance Certificate (EPC)

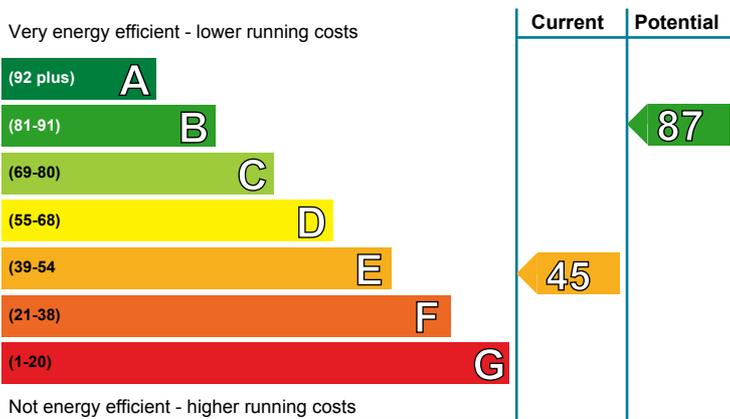
## Energy Efficiency Rating

This graph shows the current efficiency of your home, taking into account both energy efficiency and fuel costs. The higher this rating, the lower your fuel bills are likely to be.

Your current rating is **band E (45)**. The average rating for EPCs in Scotland is **band D (61)**.

The potential rating shows the effect of undertaking all of the improvement measures listed within your recommendations report.

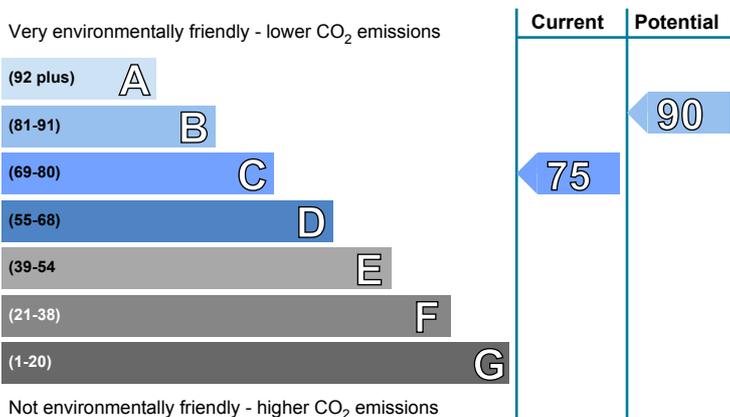
## Environmental Impact (CO<sub>2</sub>) Rating

This graph shows the effect of your home on the environment in terms of carbon dioxide (CO<sub>2</sub>) emissions. The higher the rating, the less impact it has on the environment.

Your current rating is **band C (75)**

The potential rating shows the effect of undertaking all of the improvement measures listed within your recommendations report.
