# YOUR ONESURVEY HOME REPORT

20 Citadel Place  
Motherwell  
ML1 3NT

# SINGLE SURVEY

A report on the condition of the property, with categories  
being rated from 1 to 3.

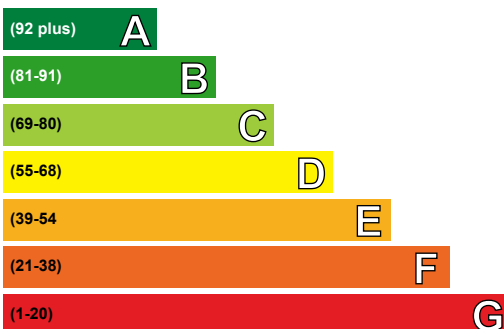
\* based upon the cost of energy for heating, hot water, lighting and ventilation, calculated using standard assumptions

Very energy efficient - lower running costs

| Current | Potential |
| 75 | 75 |

Not energy efficient - higher running costs
