Home Report

Single Survey

| Property address | 1 Bridge Street Kilbirnie KA25 7BL |
| Prepared by | Shepherd Chartered Surveyors |

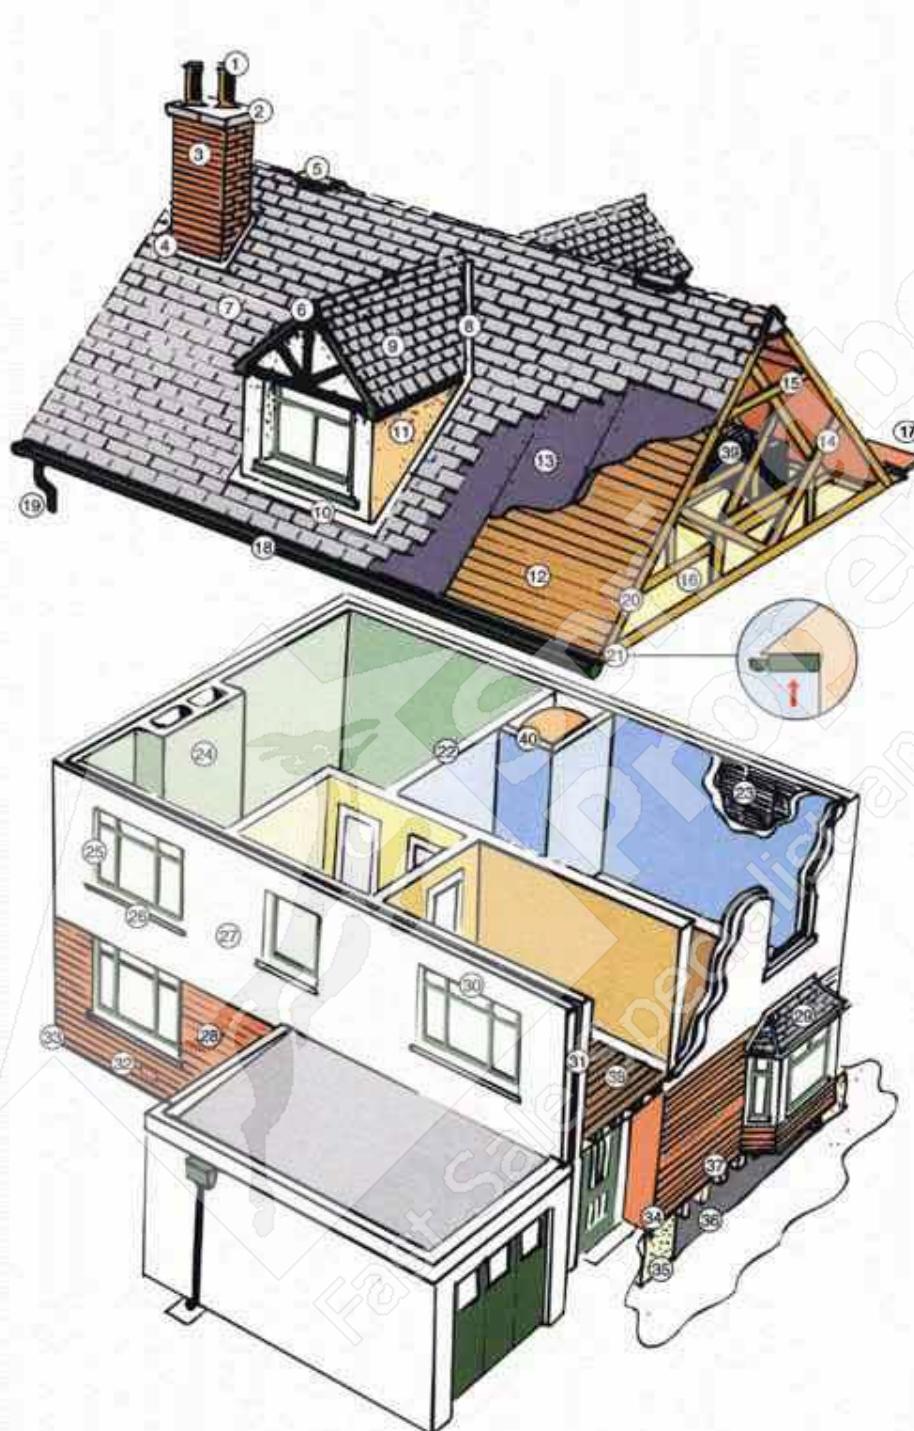
Sectional Diagram showing elements of a typical house

- 1 Chimney pots
- 2 Coping stone
- 3 Chimney head
- 4 Flashing
- 5 Ridge ventilation
- 6 Ridge board
- 7 Slates / tiles
- 8 Valley guttering
- 9 Dormer projection
- 10 Dormer flashing
- 11 Dormer cheeks
- 12 Sarking
- 13 Roof felt
- 14 Trusses
- 15 Collar
- 16 Insulation
- 17 Parapet gutter
- 18 Eaves guttering
- 19 Rainwater downpipe
- 20 Verge boards /skews
- 21 Soffit boards
- 22 Partition wall
- 23 Lath / plaster
- 24 Chimney breast
- 25 Window pointing
- 26 Window sills
- 27 Rendering
- 28 Brickwork / pointing
- 29 Bay window projection
- 30 Lintels
- 31 Cavity walls / wall ties
- 32 Subfloor ventilator
- 33 Damp proof course
- 34 Base course
- 35 Foundations
- 36 Solum
- 37 Floor joists
- 38 Floorboards
- 39 Water tank
- 40 Hot water tank

Reference may be made in this report to some or all of the above component parts of the property. This diagram may assist you in locating and understanding these items.

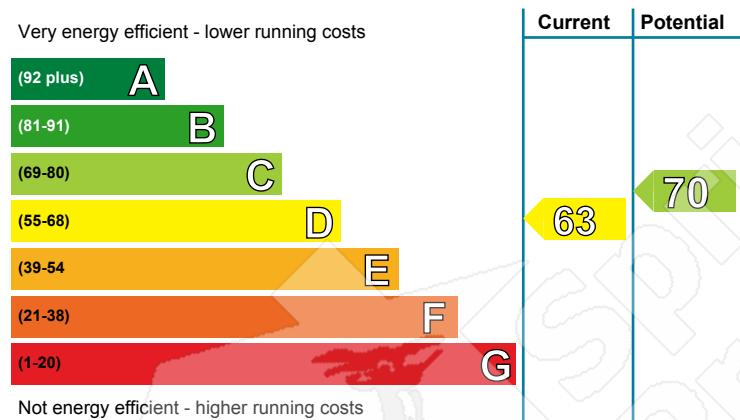
Energy Efficiency Rating

This graph shows the current efficiency of your home, taking into account both energy efficiency and fuel costs. The higher this rating, the lower your fuel bills are likely to be.

Your current rating is **band D (63)**. The average rating for EPCs in Scotland is **band D (61)**.

The potential rating shows the effect of undertaking all of the improvement measures listed within your recommendations report.

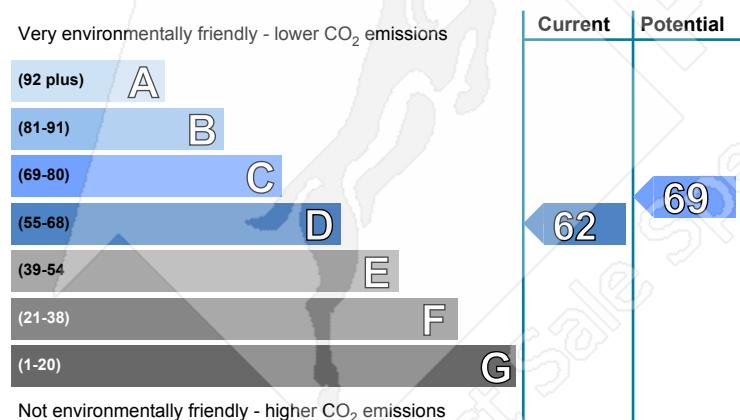
Environmental Impact (CO₂) Rating

This graph shows the effect of your home on the environment in terms of carbon dioxide (CO₂) emissions. The higher the rating, the less impact it has on the environment.
