YOUR ONESURVEY
HOME REPORT

65 Marleon Field
Elgin
IV30 4GE

SINGLE SURVEY

A report on the condition of the property, with categories being rated from 1 to 3.

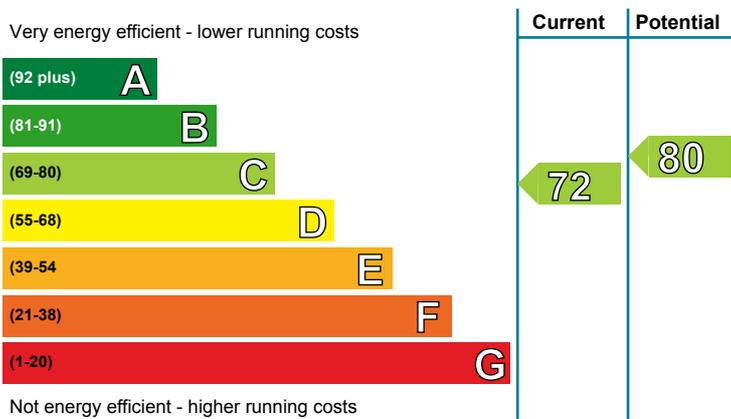
Energy Efficiency Rating

This graph shows the current efficiency of your home, taking into account both energy efficiency and fuel costs. The higher this rating, the lower your fuel bills are likely to be.

Your current rating is **band C (72)**. The average rating for EPCs in Scotland is **band D (61)**.

The potential rating shows the effect of undertaking all of the improvement measures listed within your recommendations report.

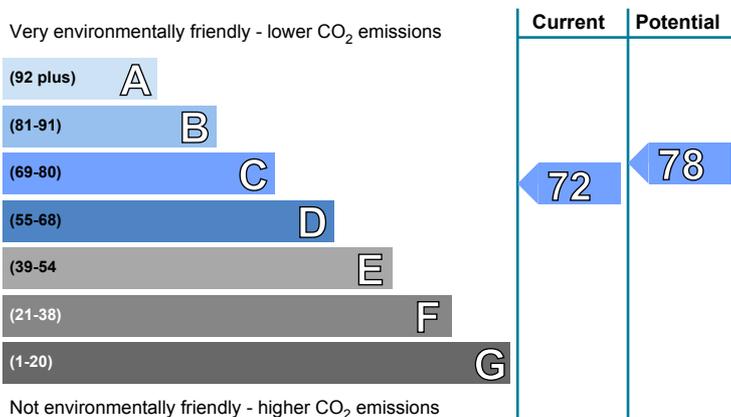
Environmental Impact (CO₂) Rating

This graph shows the effect of your home on the environment in terms of carbon dioxide (CO₂) emissions. The higher the rating, the less impact it has on the environment.
