# Home Report

# Single Survey

<b>Property Address</b>	The Old Manse Stittenham Road Helmsdale KW8 6JG
<b>Customer</b>	Helen Smith
<b>Date of Inspection</b>	02/06/2026
<b>Prepared by</b>	Jennifer Swanson Walker Fraser Steele

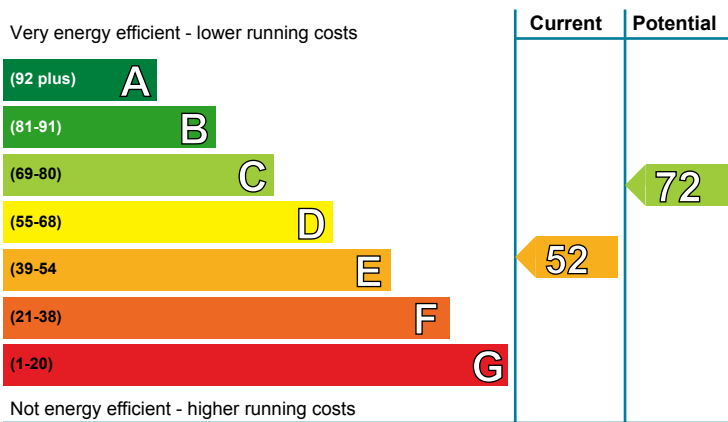
## Energy Efficiency Rating

This graph shows the current efficiency of your home, taking into account both energy efficiency and fuel costs. The higher this rating, the lower your fuel bills are likely to be.

Your current rating is **band E (52)**. The average rating for EPCs in Scotland is **band D (61)**.

The potential rating shows the effect of undertaking all of the improvement measures listed within your recommendations report.

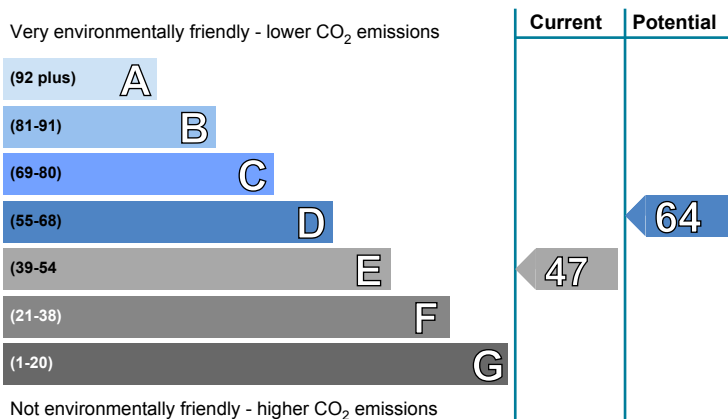
## Environmental Impact (CO<sub>2</sub>) Rating

This graph shows the effect of your home on the environment in terms of carbon dioxide (CO<sub>2</sub>) emissions. The higher the rating, the less impact it has on the environment.
