YOUR ONESURVEY
HOME REPORT

Alders
Duisdalemore
Isle Ornsay
Isle of Skye, IV43 8QX

SINGLE SURVEY

Single Survey

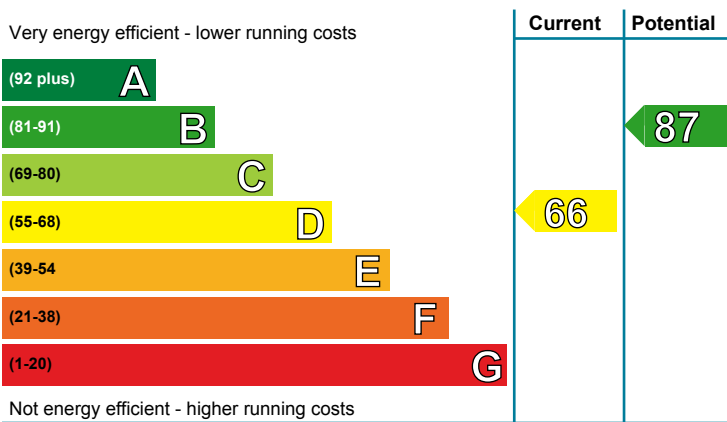
Energy Efficiency Rating

This graph shows the current efficiency of your home, taking into account both energy efficiency and fuel costs. The higher this rating, the lower your fuel bills are likely to be.

Your current rating is **band D (66)**. The average rating for EPCs in Scotland is **band D (61)**.

The potential rating shows the effect of undertaking all of the improvement measures listed within your recommendations report.

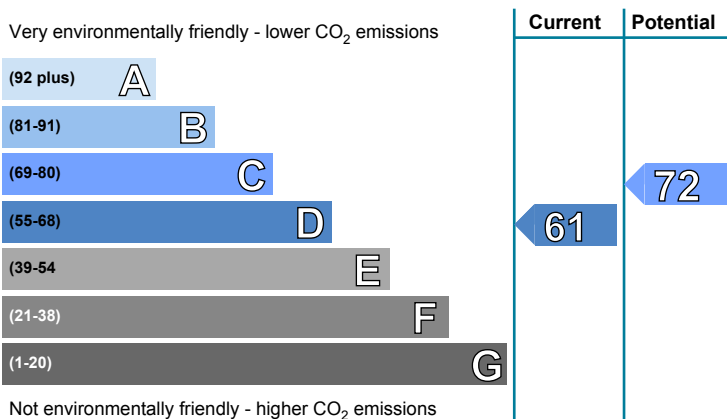
Environmental Impact (CO₂) Rating

This graph shows the effect of your home on the environment in terms of carbon dioxide (CO₂) emissions. The higher the rating, the less impact it has on the environment.
