# Home Report

66 Stirling Road,  
Fallin,  
FK7 7JL

## Survey Report on:

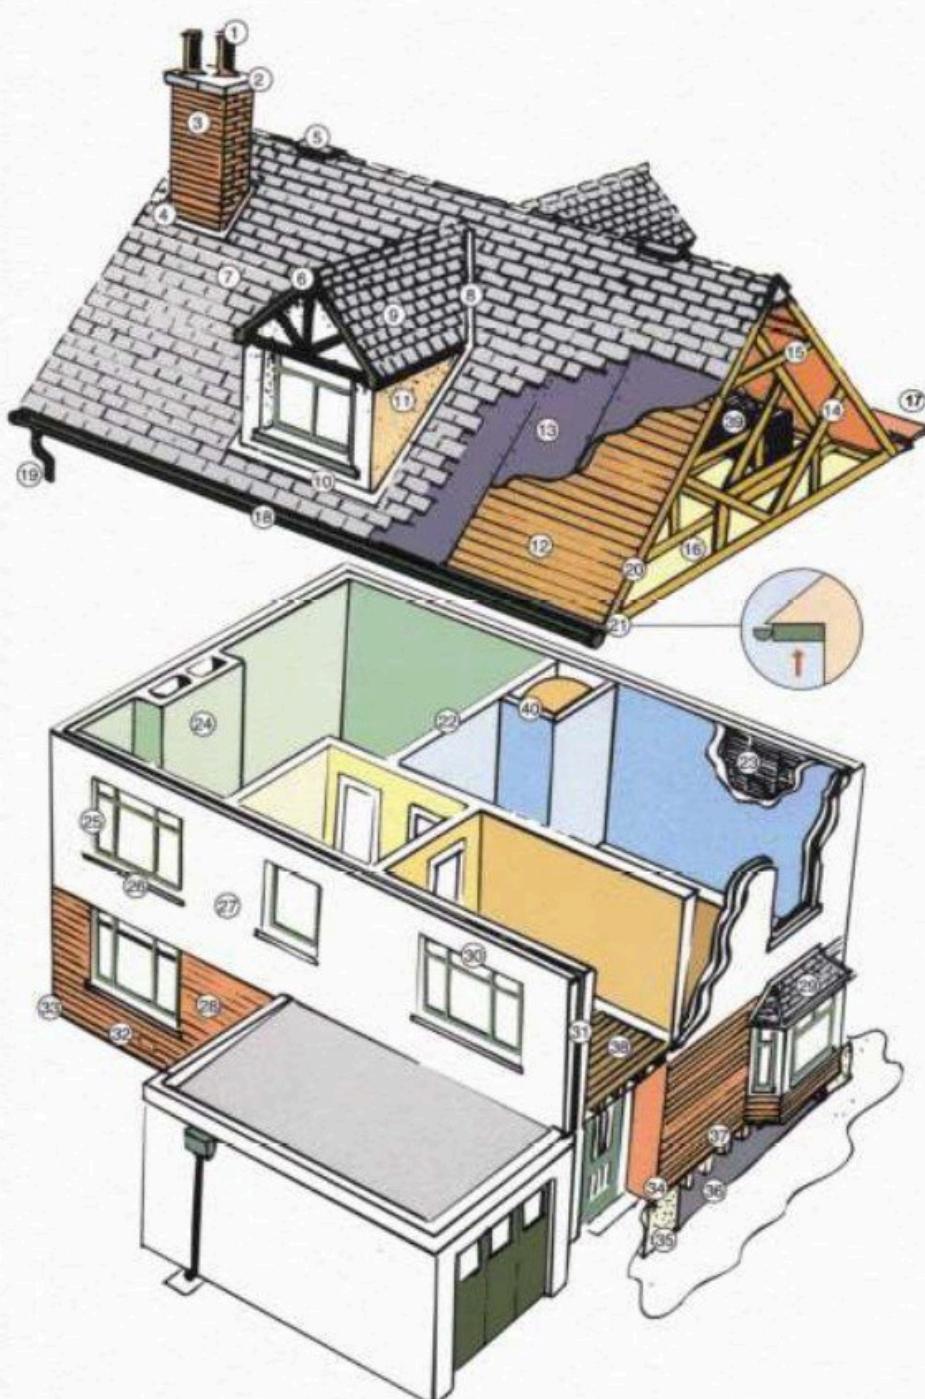
## Sectional Diagram showing elements of a typical house

- 1 Chimney pots
- 2 Coping stone
- 3 Chimney head
- 4 Flashing
- 5 Ridge ventilation
- 6 Ridge board
- 7 Slates / tiles
- 8 Valley guttering
- 9 Dormer projection
- 10 Dormer flashing
- 11 Dormer cheeks
- 12 Sarking
- 13 Roof felt
- 14 Trusses
- 15 Collar
- 16 Insulation
- 17 Parapet gutter
- 18 Eaves guttering
- 19 Rainwater downpipe
- 20 Verge boards / skewers
- 21 Soffit boards
- 22 Partition wall
- 23 Lath / plaster
- 24 Chimney breast
- 25 Window pointing
- 26 Window sills
- 27 Rendering
- 28 Brickwork / pointing
- 29 Bay window projection
- 30 Lintels
- 31 Cavity walls / wall ties
- 32 Subfloor ventilator
- 33 Damp proof course
- 34 Base course
- 35 Foundations
- 36 Solum
- 37 Floor joists
- 38 Floorboards
- 39 Water tank
- 40 Hot water tank

Reference may be made in this report to some or all of the above component parts of the property. This diagram may assist you in locating and understanding these items.
