Home Report

Scottish Single Survey

Property address	3 St. Andrew Street Galashiels TD1 1EA
Customer	Richard Montgomery
Customer address	3 St. Andrew Street Galashiels TD1 1EA
Prepared by	Shepherd Chartered Surveyors
Date of inspection	04/02/2026

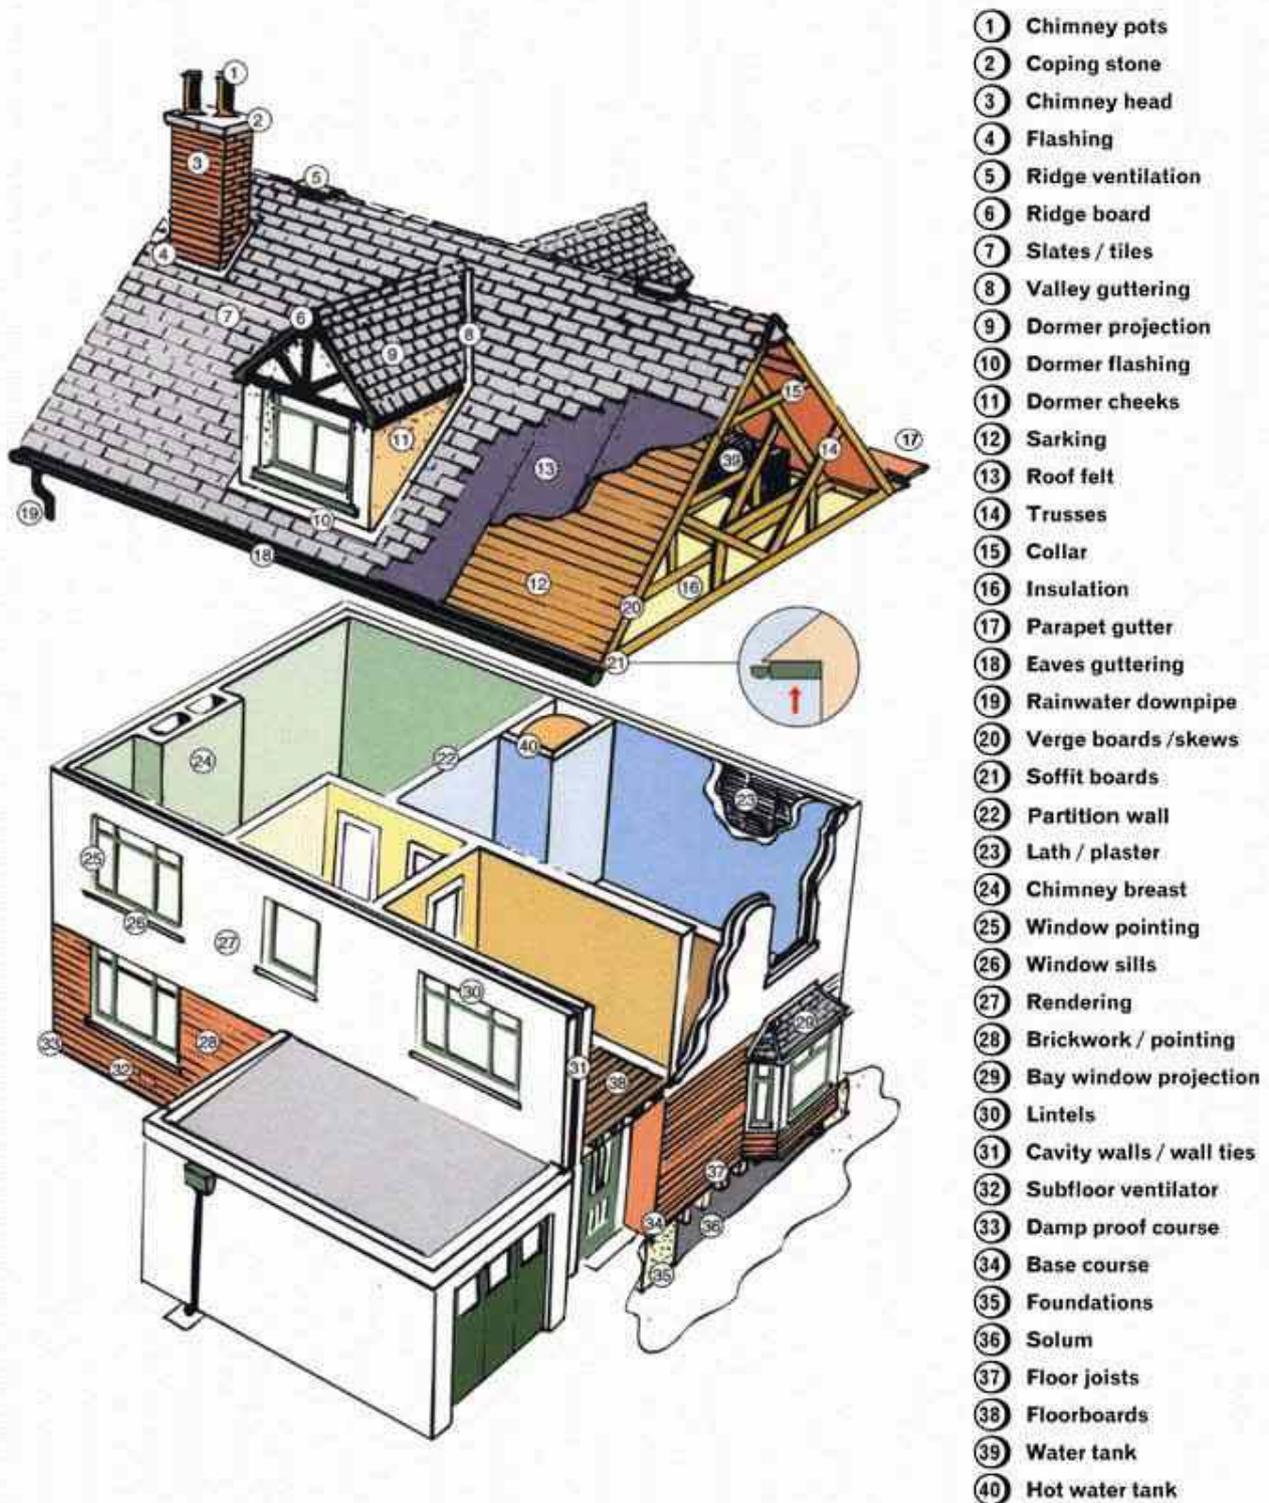
Sectional Diagram showing elements of a typical house

Reference may be made in this report to some or all of the above component parts of the property. This diagram may assist you in locating and understanding these items.
