Home Report

4 Gillies Park Mallaig PH41 4QU

Prepared by:
Samuel & Partners
First Surveyors Scotland
First Floor
20 High Street
FORT WILLIAM
PH33 6AT

1. Property Questionnaire
2. Single Survey
3. Mortgage Valuation
4. Energy Report

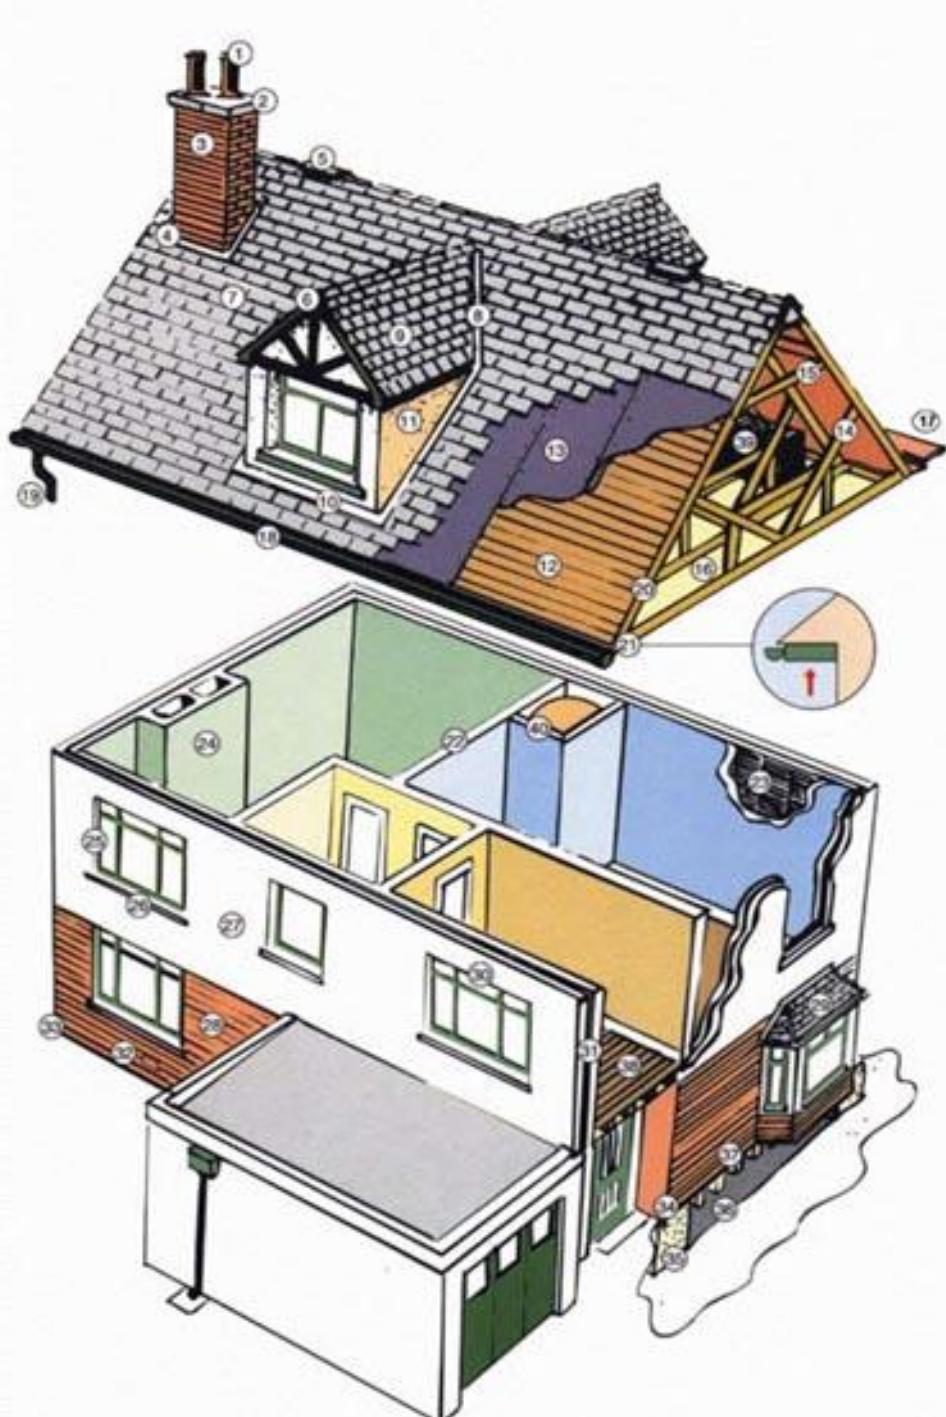
Sectional Diagram showing elements of a typical house

- 1 Chimney pots
- 2 Coping stone
- 3 Chimney head
- 4 Flashing
- 5 Ridge ventilation
- 6 Ridge board
- 7 Slates / tiles
- 8 Valley guttering
- 9 Dormer projection
- 10 Dormer flashing
- 11 Dormer cheeks
- 12 Sarking
- 13 Roof felt
- 14 Trusses
- 15 Collar
- 16 Insulation
- 17 Parapet gutter
- 18 Eaves guttering
- 19 Rainwater downpipe
- 20 Verge boards / skewers
- 21 Soffit boards
- 22 Partition wall
- 23 Lath / plaster
- 24 Chimney breast
- 25 Window pointing
- 26 Window sills
- 27 Rendering
- 28 Brickwork / pointing
- 29 Bay window projection
- 30 Lintels
- 31 Cavity walls / wall ties
- 32 Subfloor ventilator
- 33 Damp proof course
- 34 Base course
- 35 Foundations
- 36 Solum
- 37 Floor joists
- 38 Floorboards
- 39 Water tank
- 40 Hot water tank

Reference may be made in this report to some or all of the above component parts of the property. This diagram may assist you in locating and understanding these items.

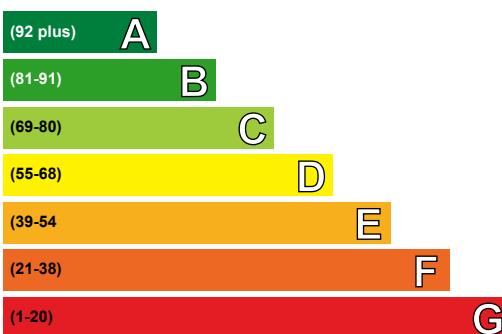
Energy Efficiency Rating

Very energy efficient - lower running costs

Not energy efficient - higher running costs
