# Home Report

## Tigh Mo Mhiann Bunroy Roy Bridge PH31 4AG

Inspected on: 15<sup>th</sup> July 2026

**Prepared by:**  
Samuel & Partners  
First Surveyors Scotland  
First Floor  
20 High Street  
FORT WILLIAM  
PH33 6AT

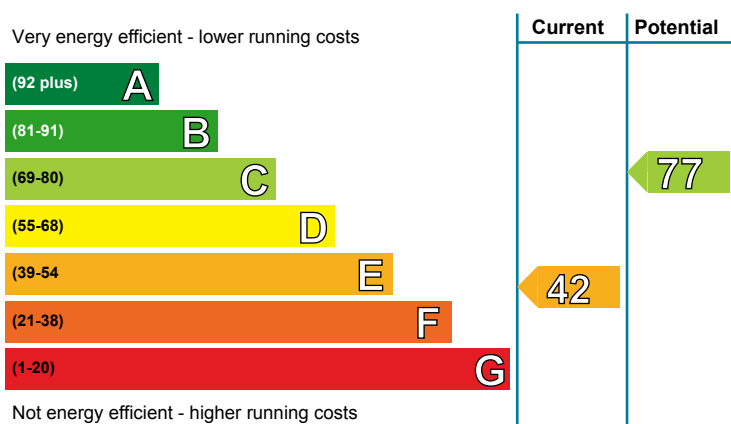
## Energy Efficiency Rating

This graph shows the current efficiency of your home, taking into account both energy efficiency and fuel costs. The higher this rating, the lower your fuel bills are likely to be.

Your current rating is **band E (42)**. The average rating for EPCs in Scotland is **band D (61)**.

The potential rating shows the effect of undertaking all of the improvement measures listed within your recommendations report.

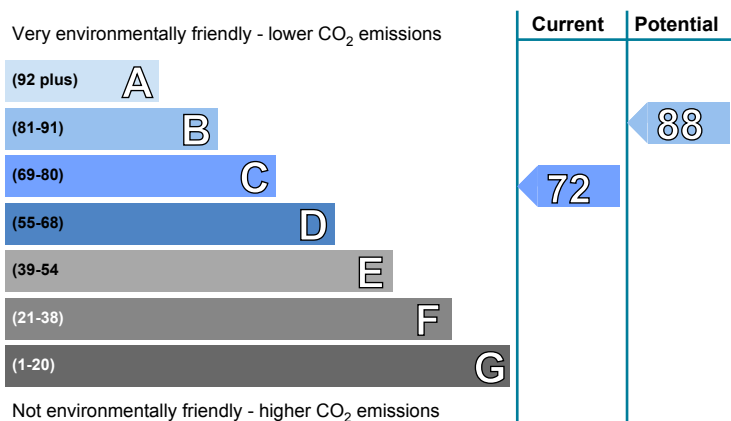
## Environmental Impact (CO<sub>2</sub>) Rating

This graph shows the effect of your home on the environment in terms of carbon dioxide (CO<sub>2</sub>) emissions. The higher the rating, the less impact it has on the environment.
