Home Report

Scottish Single Survey

Property address	32 Kerrera Road Glasgow G33 4QZ
Customer	L Fury
Customer address	32 Kerrera Road Glasgow G33 4QZ
Prepared by	Shepherd Chartered Surveyors
Date of inspection	26/05/2026

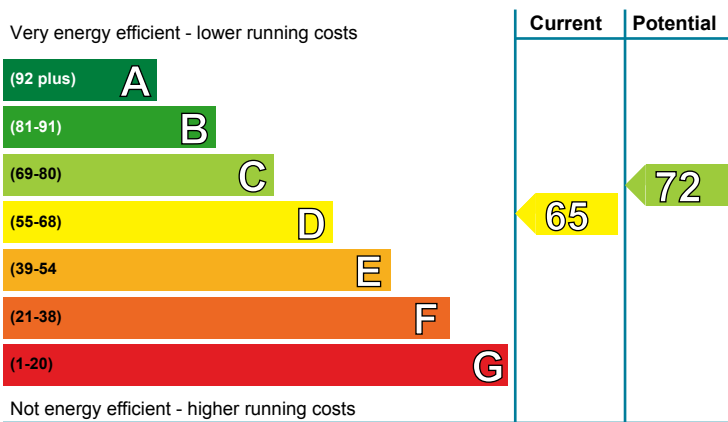
Energy Efficiency Rating

This graph shows the current efficiency of your home, taking into account both energy efficiency and fuel costs. The higher this rating, the lower your fuel bills are likely to be.

Your current rating is **band D (65)**. The average rating for EPCs in Scotland is **band D (61)**.

The potential rating shows the effect of undertaking all of the improvement measures listed within your recommendations report.

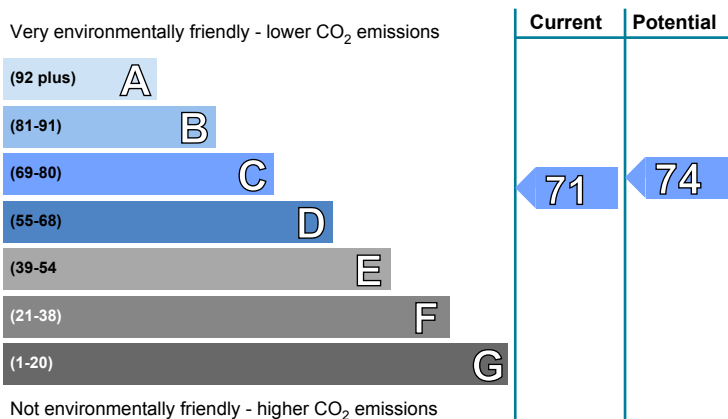
Environmental Impact (CO₂) Rating

This graph shows the effect of your home on the environment in terms of carbon dioxide (CO₂) emissions. The higher the rating, the less impact it has on the environment.
