# YOUR ONESURVEY HOME REPORT

Flat 42 Roseburn House  
6 Roseburn Drive  
Edinburgh  
EH12 5NS

# SINGLE SURVEY

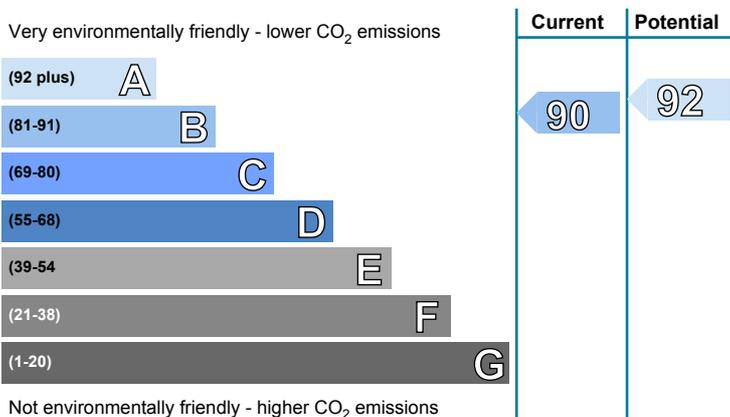
## Environmental Impact (CO<sub>2</sub>) Rating

This graph shows the effect of your home on the environment in terms of carbon dioxide (CO<sub>2</sub>) emissions. The higher the rating, the less impact it has on the environment.
