# Home Report

# Single Survey

survey report on:

| Property address | 23/2 Hopetoun Street<br>Edinburgh<br>EH7 4NF |

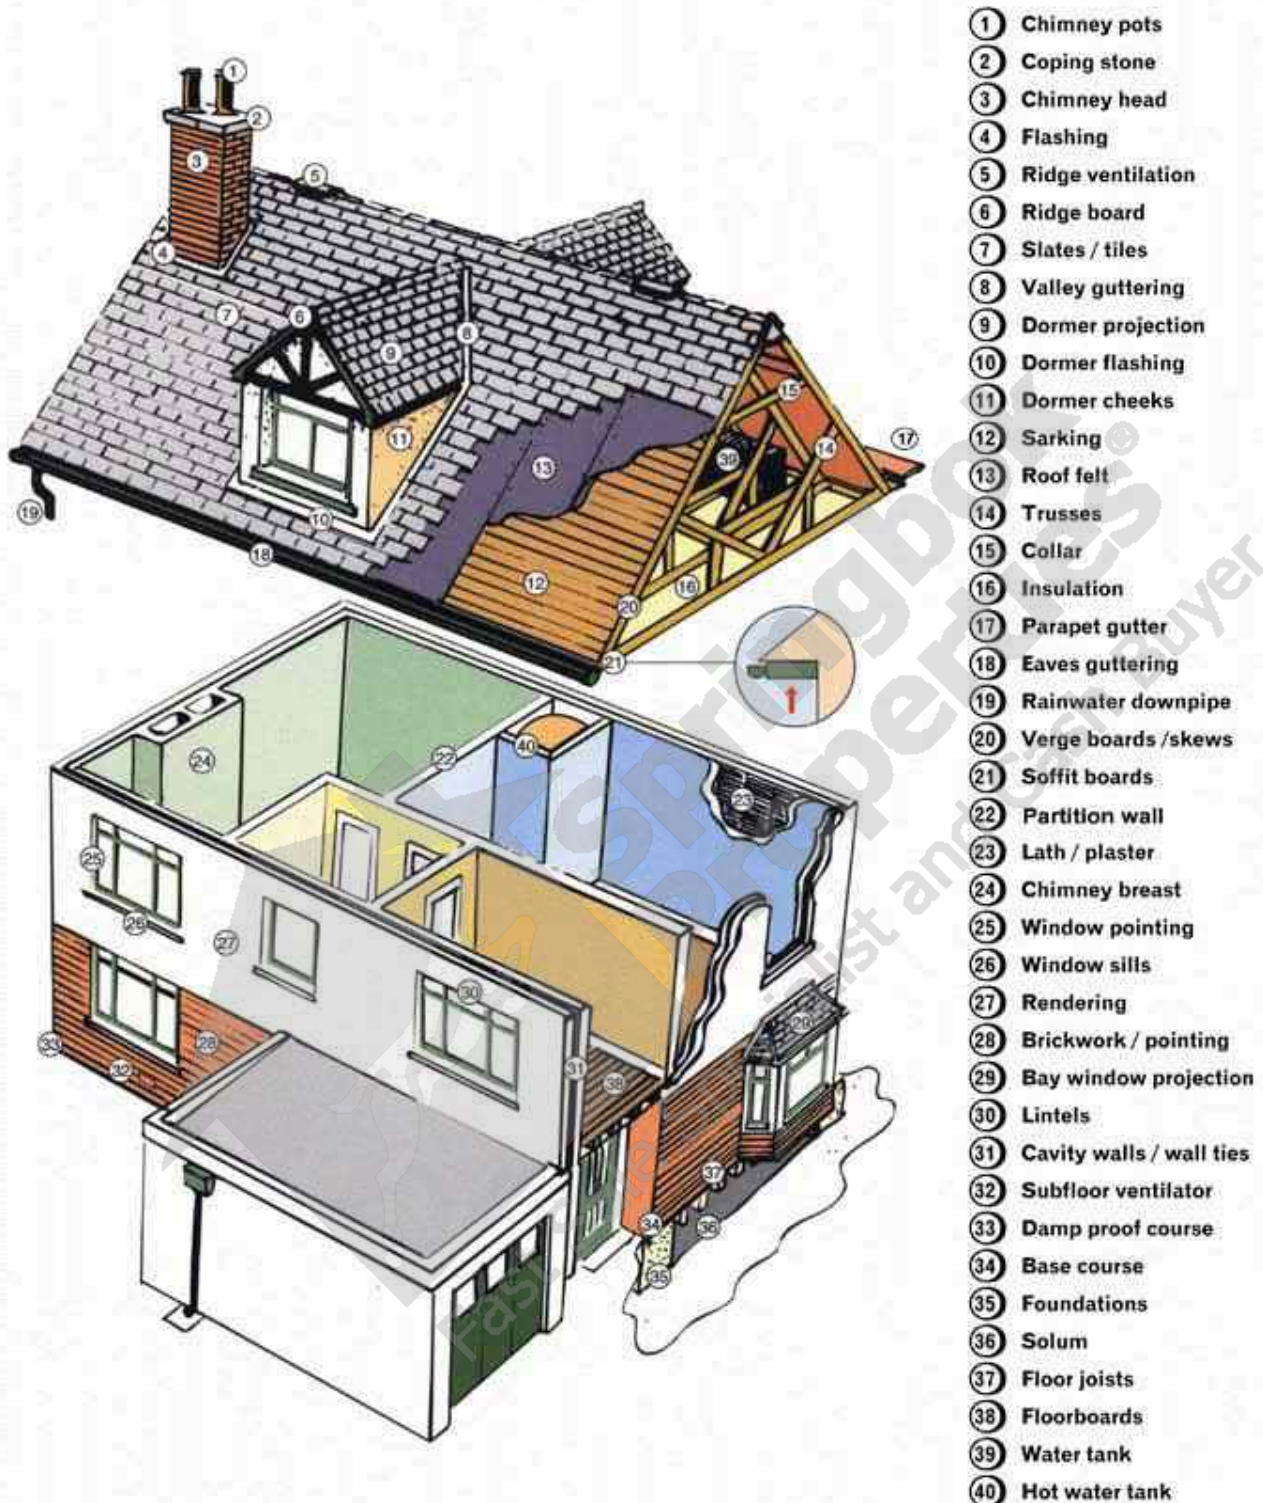
## Sectional Diagram showing elements of a typical house

Reference may be made in this report to some or all of the above component parts of the property. This diagram may assist you in locating and understanding these items.

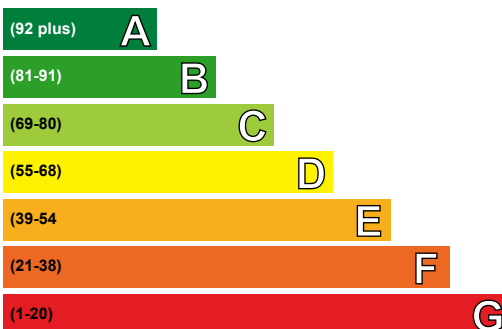
Very energy efficient - lower running costs

| Current | Potential |
| 72 | 72 |

Not energy efficient - higher running costs

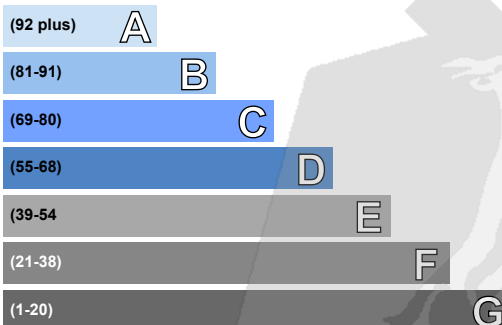
Very environmentally friendly - lower CO<sub>2</sub> emissions

| Current | Potential |
| 73 | 73 |
