Home Report

Single Survey

Property address	70 Obsdale Park Alness IV17 0TR
Customer	Adam Gunn
Customer address	70 Obsdale Park Alness IV17 0TR
Prepared by	Shepherd Chartered Surveyors
Date of inspection	27/05/2026

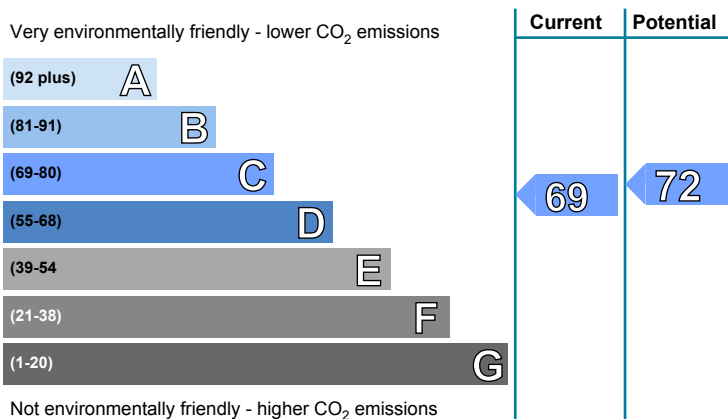
Environmental Impact (CO₂) Rating

This graph shows the effect of your home on the environment in terms of carbon dioxide (CO₂) emissions. The higher the rating, the less impact it has on the environment.
