Home Report

Balnaculloch House
Ardersier Inverness IV2 7QN

Single Survey

Property Address	Balnaculloch House Ardersier Inverness IV2 7QN
Customer	Mr and Mrs Harvey
Prepared by	Graham + Sibbald Property Consultants Limited
Date of Inspection	29/04/2026

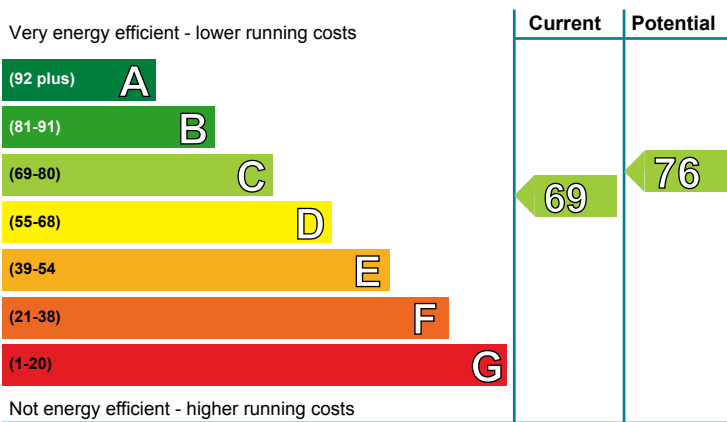
Energy Efficiency Rating

This graph shows the current efficiency of your home, taking into account both energy efficiency and fuel costs. The higher this rating, the lower your fuel bills are likely to be.

Your current rating is **band C (69)**. The average rating for EPCs in Scotland is **band D (61)**.

The potential rating shows the effect of undertaking all of the improvement measures listed within your recommendations report.

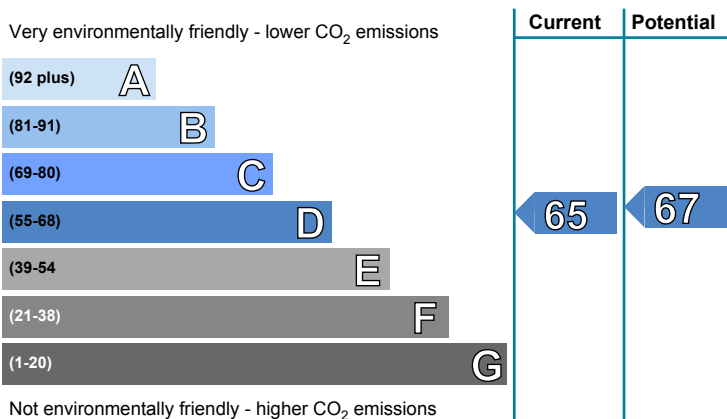
Environmental Impact (CO₂) Rating

This graph shows the effect of your home on the environment in terms of carbon dioxide (CO₂) emissions. The higher the rating, the less impact it has on the environment.
