Home Report

16 Montague Street
Broughty Ferry Dundee DD5 2RD

Single Survey

Property Address	16 Montague Street Broughty Ferry Dundee DD5 2RD
Customer	Executor of the Late Dr Joyce M Watson
Prepared by	Graham + Sibbald Property Consultants Limited
Date of Inspection	10/06/2026

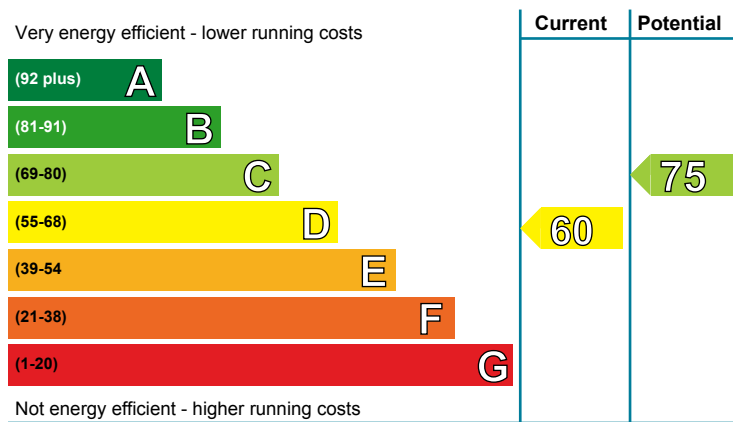
Energy Efficiency Rating

This graph shows the current efficiency of your home, taking into account both energy efficiency and fuel costs. The higher this rating, the lower your fuel bills are likely to be.

Your current rating is **band D (60)**. The average rating for EPCs in Scotland is **band D (61)**.

The potential rating shows the effect of undertaking all of the improvement measures listed within your recommendations report.

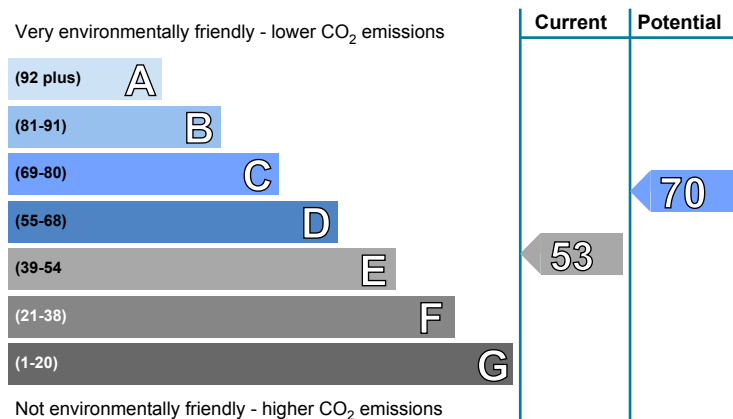
Environmental Impact (CO₂) Rating

This graph shows the effect of your home on the environment in terms of carbon dioxide (CO₂) emissions. The higher the rating, the less impact it has on the environment.
