# home report

**10C SIDNEY STREET  
SALTCOATS  
KA21 5DD**

# Energy Performance Certificate (EPC)

# Single Survey

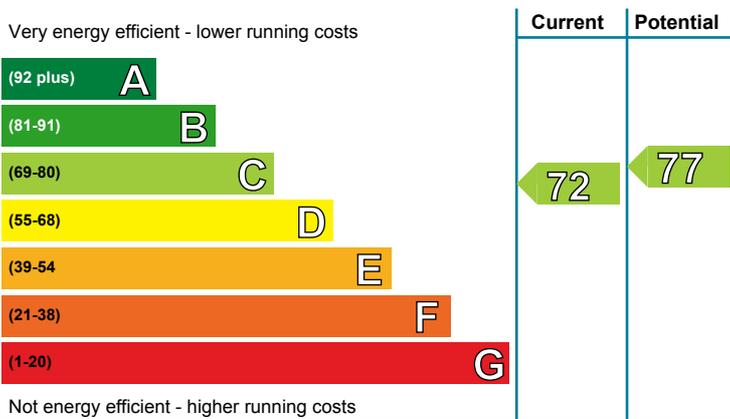
## Energy Efficiency Rating

This graph shows the current efficiency of your home, taking into account both energy efficiency and fuel costs. The higher this rating, the lower your fuel bills are likely to be.

Your current rating is **band C (72)**. The average rating for EPCs in Scotland is **band D (61)**.

The potential rating shows the effect of undertaking all of the improvement measures listed within your recommendations report.

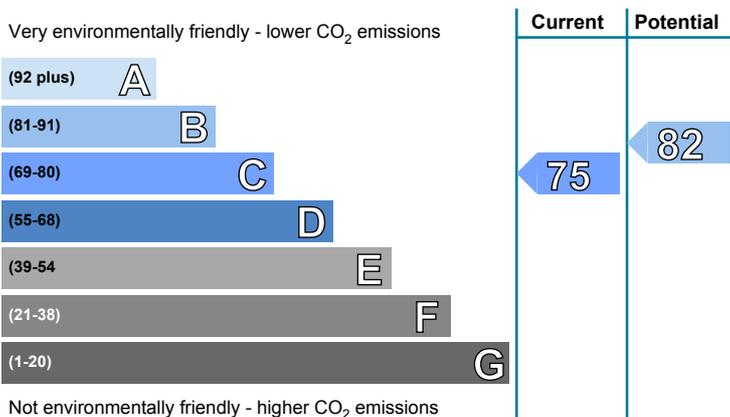
## Environmental Impact (CO<sub>2</sub>) Rating

This graph shows the effect of your home on the environment in terms of carbon dioxide (CO<sub>2</sub>) emissions. The higher the rating, the less impact it has on the environment.

Your current rating is **band C (75)**

The potential rating shows the effect of undertaking all of the improvement measures listed within your recommendations report.
