Home Report

Single Survey

3c Reay Street,
Inverness,
IV2 3AJ

SINGLE SURVEY TERMS AND CONDITIONS (WITH MVR)

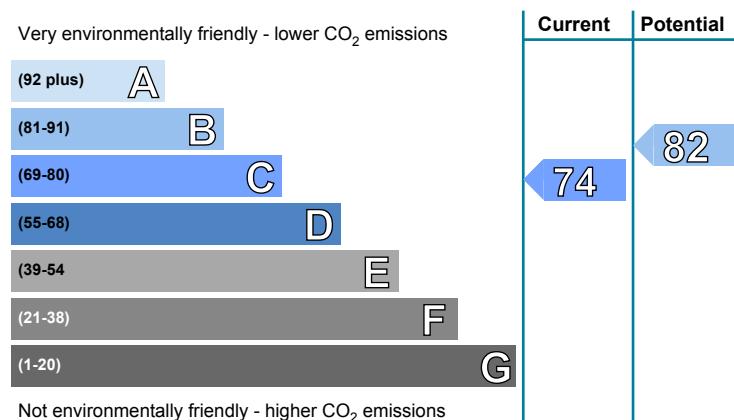
Environmental Impact (CO₂) Rating

This graph shows the effect of your home on the environment in terms of carbon dioxide (CO₂) emissions. The higher the rating, the less impact it has on the environment.
