Single Survey

Property address	Bankhead Farm and Cottage, Banff, AB45 2LQ
Customer	Mr Fittall
Customer address	Bankhead Farm and Cottage, Boyndie, Banff, AB45 2LQ
Prepared by	DM Hall LLP
Date of inspection	4th December 2025

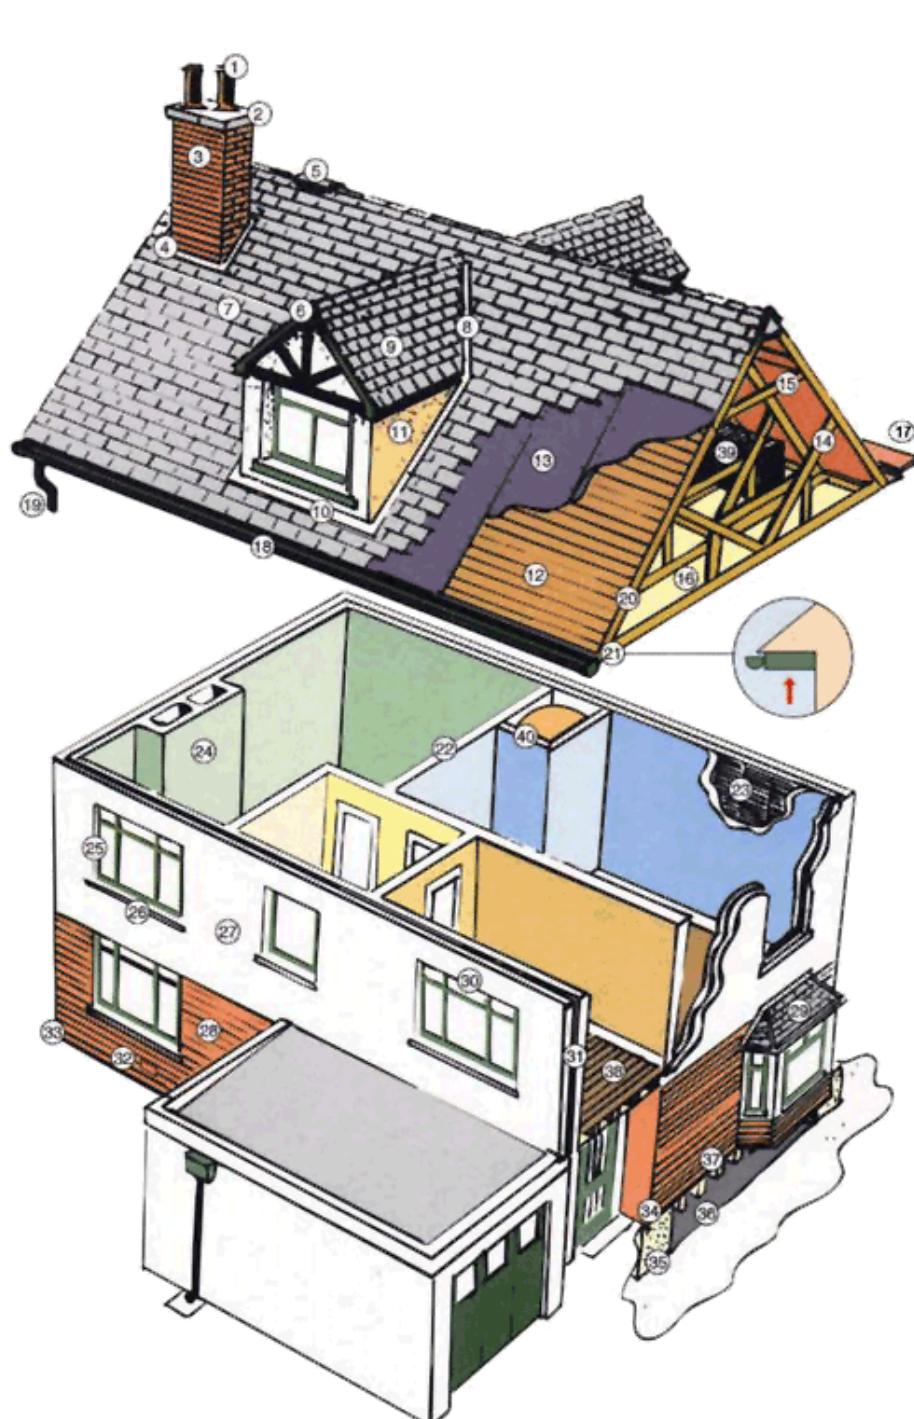
Sectional Diagram showing elements of a typical house

- 1 Chimney pots
- 2 Coping stone
- 3 Chimney head
- 4 Flashing
- 5 Ridge ventilation
- 6 Ridge board
- 7 Slates / tiles
- 8 Valley guttering
- 9 Dormer projection
- 10 Dormer flashing
- 11 Dormer cheeks
- 12 Sarking
- 13 Roof felt
- 14 Trusses
- 15 Collar
- 16 Insulation
- 17 Parapet gutter
- 18 Eaves guttering
- 19 Rainwater downpipe
- 20 Verge boards /skews
- 21 Soffit boards
- 22 Partition wall
- 23 Lath / plaster
- 24 Chimney breast
- 25 Window pointing
- 26 Window sills
- 27 Rendering
- 28 Brickwork / pointing
- 29 Bay window projection
- 30 Lintels
- 31 Cavity walls / wall ties
- 32 Subfloor ventilator
- 33 Damp proof course
- 34 Base course
- 35 Foundations
- 36 Solum
- 37 Floor joists
- 38 Floorboards
- 39 Water tank
- 40 Hot water tank

Reference may be made in this report to some or all of the above component parts of the property. This diagram may assist you in locating and understanding these items.
