## In-service Inspection and Test of Electrical Equipment

LOCH EWE AULTBEA CRS

## ELECTRICAL INSTALLATION CONDITION REPORT

## Asbestos Reinspection Report

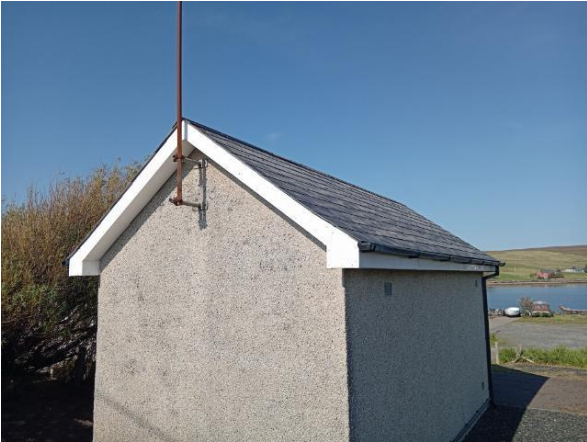
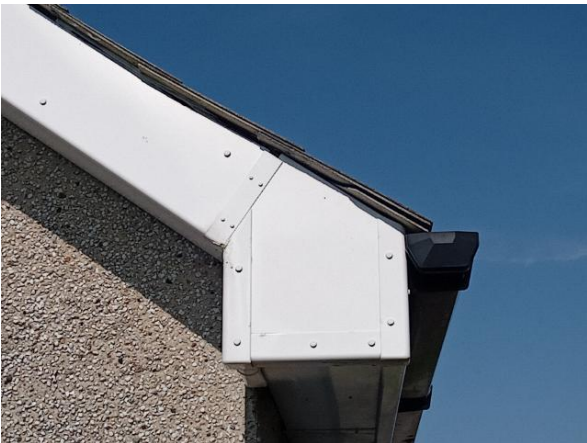
| Sample Reference Number | |
|---|---|
| <u>P NST cement roof tiles</u> | |

| Material Assessment | | |
|---|---|---|
| Condition | 0. Good | |

| Notes |
|---|
| Re-inspected on 18/8/2025 by Scot Ferguson. No change to condition of roof tiles, continue to presume the presence of ACM's until proven otherwise. No damage internally to pitched roof viewed through internal loft hatch. |
